Access Compliance Report

Public Rights-of-Way

(Curb Ramps)

Intersection ID: 14710	Main Street: LYNDHURST_AV	Cross Street: MCDONALD_AV	Location: E
ADA ID: 55255DAE2273	Ramp Type: Directional1	Initial Pass/Fail: Fail	Overall Compliance: No
Severity Score: 1.25			
Codes/Mitigation Info/Possible Solution		Field Measurements/Component Compliance

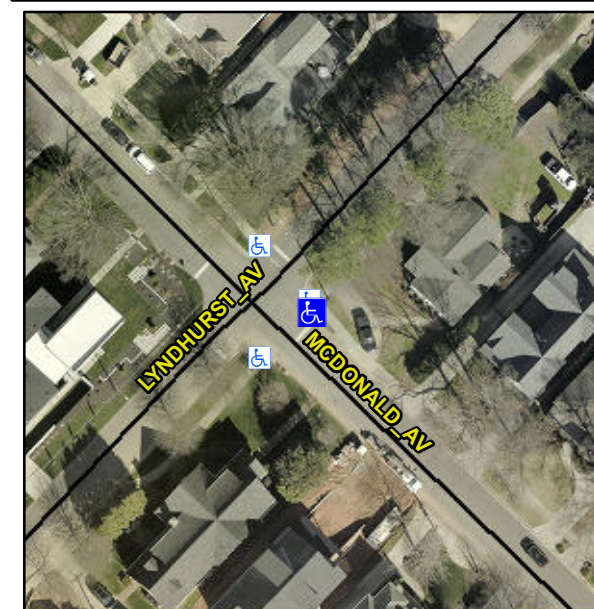
Compliance	Description	Data	Compliance	Description	Data
N/A	Ramp Length (in)	106.0	N/A	Grade Break?	N/A
Yes	Ramp Width (in)	57.0	N/A	Grade Break Slope (%)	0.0
Yes	Ramp Slope (%)	6.9	N/A	Grade Break XSlope (%)	0.0
No	Ramp XSlope (%)	4.1			
N/A	Flare Type LT	N/A	N/A	Flare Type RT	N/A
N/A	Flare Slope LT (%)	N/A	N/A	Flare Slope RT (%)	0.0
N/A	Flare Traversable LT?	N/A	N/A	Flare Traversable RT?	N/A
N/A	Landing Length (in)	0.0	N/A	DWS Provided?	N/A
N/A	Landing Width (in)	0.0	N/A	DWS Contrast?	N/A
N/A	Landing Slope (%)	0.0	N/A	DWS Length (in)	N/A
N/A	Landing X Slope (%)	0.0	N/A	DWS Full Width?	N/A
N/A	Landing Curb? (Y/N)	N/A	N/A	DWS Offset LT (in)	N/A
N/A	Shared Landing?	N/A	N/A	DWS Offset RT (in)	N/A
N/A	Gutter Ponding?	0.0	N/A	Gutter Slope (%)	N/A
N/A	Gutter Lip Ht (in)	1.0	N/A	Gutter X Slope (%)	N/A
N/A	Painted X Walk1?	No		Road Slope (%)	5.1
	X Walk 1 Direction	To SW		Road X Slope (%)	0.2
	X Walk 1 Width (in)	N/A		Clear Space?	N/A

X Walk 1 Slope (%)	5.1	N/A	Clear Space to XWalk (in)	N/A
	X Walk 1 X Slope (%)	0.2	N/A	Storm Grate/Utility Hazard?	N/A
N/A	Ramp inside XWalk1?	N/A		Storm Grate/Utility Type	
N/A	Any Obstructions?	N/A			N/A
	Obstruction Type		Yes	Surface Condition? (G/P)	Good
			N/A	Curb Slope (%)	10.2

Possible Solutions:

Remove & Replace Entire Ramp.
