## **Access Compliance Report Public Rights-of-Way** (Curb Ramps)

Intersection ID: 10146 Main Street: TUCKASEEGEE\_RD Cross Street: YAHTZEE\_LN Location: SE **Severity Score: Overall Compliance: No ADA ID: 5531FC61DB0F** Ramp Type: Perp Initial Pass/Fail: Pass 20

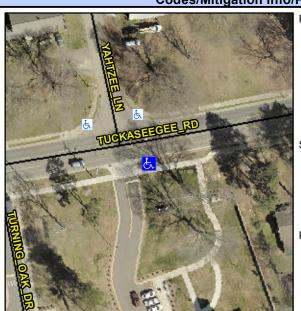
Field Measurements/Component Compliance								
Comp	liance Description	Data	Comp	liance	Description	Data		
N/A	Ramp Length (in)	79.0	Yes	Ramp	Slope (%)	7.0		
Yes	Ramp Width (in)	51.0	Yes	Ramp	XSlope (%)	1.2		
N/A	Flare Type LT	Sloped	N/A	Flare	Type RT	N/A		
N/A	Flare Slope LT (%)	5.5	Yes	Flare	Slope RT (%)	7.4		
N/A	Flare Traversable LT?	Yes	N/A	Flare	Traversable RT?	Yes		
No	Landing Length (in)	N/A	No	DWS	Provided?	No		
No	Landing Width (in)	N/A	N/A	DWS	Contrast?	No		
No	Landing Slope (%)	N/A	N/A	DWS	Length (in)	N/A		
No	Landing X Slope (%)	N/A	N/A	DWS	Full Width?	No		
N/A	Landing Curb? (Y/N)	No	N/A	DWS	Offset (in)	N/A		
N/A	Shared Landing?	No						
Yes	Gutter Ponding?	No	Yes	Gutte	r Slope (%)	1.3		
Yes	Gutter Lip Ht (in)	0.0	Yes	Gutte	r X Slope (%)	0.8		
N/A	Painted X Walk1?	No	N/A	Paint	ed X Walk2?	N/A		
	X Walk 1 Direction	To N		X Wa	lk 2 Direction	N/A		
N/A	X Walk 1 Width (in)	N/A	N/A	X Wa	lk 2 Width (in)	N/A

X Walk 1 Slope (%)	2.8		X Wa	lk 2 Slope (%)	N/A		
	X Walk 1 X Slope (%)	1.3		X Wa	lk 2 X Slope (%)	N/A		
N/A	Ramp inside XWalk1?	N/A	N/A	Ram	inside XWalk2?	N/A		
	Road Slope (%)	N/A	N/A	Clear	Space?	Yes		
	Road X Slope (%)	N/A	N/A	Clear	Space to XWalk (in)	N/A		
Yes	Any Obstructions?	No	Yes	Storn	n Grate/Utility Hazard?	No		
	Obstruction Type			Storn	n Grate/Utility Type			
		N/A				N/A		
			Yes	Surfa	ce Condition? (G/P)	Good		
	THE PROPERTY OF THE PARTY OF TH

•		
	Possible Solutions:	<u>c</u>
	Remove & Replace Entire Ramp.	N.
Store L	•	Y
STATE OF THE PARTY		N
		N.
-		N.
		N
100	Surveyor Notes:	N
1	N/A	N
į		N
		N.
B 1.8		N.
1	PROW/ADA:	Y
100	Not Found, R304.2.1, R304.2.2-Perp,	Ye
	R304.3.2-Para, R304.5.3, R305	N.
1		N.
		N.

Total Cost:	\$ 1850.00
