Access Compliance Report

Public Rights-of-Way

(Curb Ramps)

| Intersection ID: 8126 | Main Street: IRMA_ST | Cross Street: NEWLAND_RD | Location: SE |

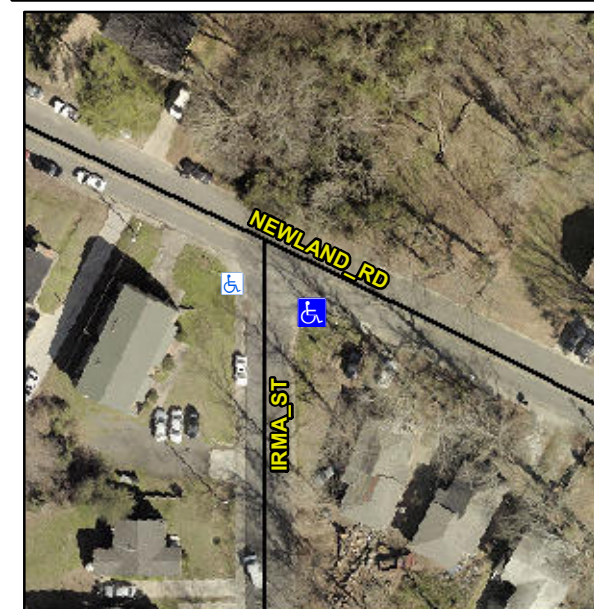
| ADA ID: 5543EBAE0EC0 | Ramp Type: Perp | Initial Pass/Fail: Fail | Overall Compliance: No |
| Severity Score: 26.25 | | | |

Not Found, R304.2.2, R304.5.3

| Compliance | Description | Data | Compliance | Description | Data |
|---|---|---|---|---|---|
| N/A | Ramp Length (in) | 38.0 | No | Ramp Slope (%) | 17.7 |
| Yes | Ramp Width (in) | 60.0 | No | Ramp XSlope (%) | 3.6 |

Remove & Replace Entire Ramp.

Total Cost: \$ 1850.00
