# Access Compliance Report

## Public Rights-of-Way

### (Curb Ramps)

| Intersection ID: 14681 | Main Street: FAIRWOOD_AV | Cross Street: GRIFFITH_ST | Location: SW |

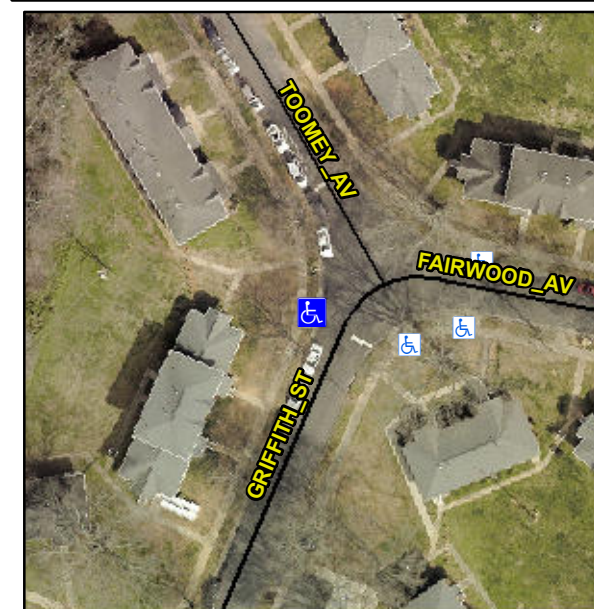
| ADA ID: 555DD152A4EB | Ramp Type: Perp | Initial Pass/Fail: Fail | Overall Compliance: No |
| Severity Score: 13.75 | | | |

| Compliance | Description | Data | Compliance | Description | Data |
|---|---|---|---|---|---|
| N/A | Ramp Length (in) | 65.0 | No | Ramp Slope (%) | 10.4 |
| Yes | Ramp Width (in) | 48.0 | No | Ramp XSlope (%) | 2.1 |

**Remove & Replace Entire Ramp.**

**R304.2.2, R304.5.3**

**\$ 1850.00**
