Access Compliance Report

Public Rights-of-Way

(Curb Ramps)

Intersection ID: 16765	Main Street: CHURCHILL_RD	Cross Street: N_WENDOVER_RD	Location: NW
ADA ID: 55897ABA6C5F	Ramp Type: PerpDiag	Initial Pass/Fail: Fail	Overall Compliance: No
Severity Score: 22.5			
Codes/Mitigation Info/Possible Solution		Field Measurements/Component Compliance

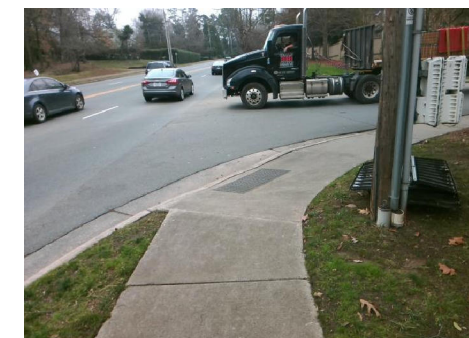
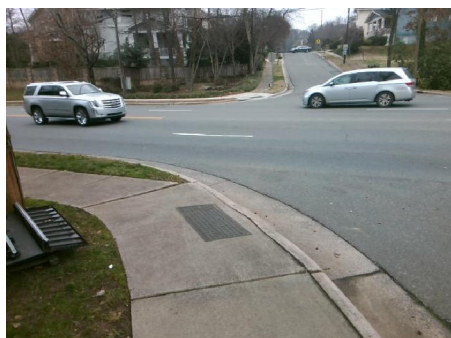
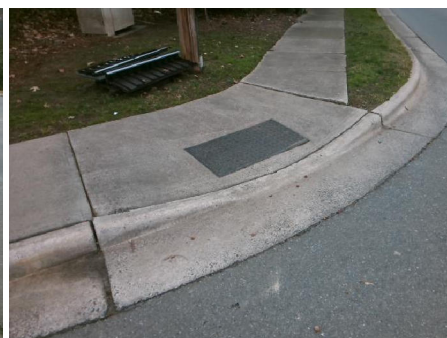
Not Found, R304.5.1, R304.2.2, R304.5.3

Compliance	Description	Data	Compliance	Description	Data
N/A	Ramp Length (in)	68.0	No	Ramp Slope (%)	10.1
No	Ramp Width (in)	44.0	No	Ramp XSlope (%)	2.8
N/A	Flare Type LT	N/A	N/A	Flare Type RT	N/A
N/A	Flare Slope LT (%)	N/A	N/A	Flare Slope RT (%)	N/A
N/A	Flare Traversable LT?	N/A	N/A	Flare Traversable RT?	N/A
N/A	Landing Length (in)	N/A	N/A	DWS Provided?	N/A
N/A	Landing Width (in)	N/A	N/A	DWS Contrast?	N/A
N/A	Landing Slope (%)	N/A	N/A	DWS Length (in)	N/A
N/A	Landing X Slope (%)	N/A	N/A	DWS Full Width?	N/A
N/A	Landing Curb? (Y/N)	N/A	N/A	DWS Offset (in)	N/A
N/A	Shared Landing?	N/A			
N/A	Gutter Ponding?	N/A	N/A	Gutter Slope (%)	N/A
N/A	Gutter Lip Ht (in)	N/A	N/A	Gutter X Slope (%)	N/A
N/A	Painted X Walk1?	No	N/A	Painted X Walk2?	No
	X Walk 1 Direction	To S		X Walk 2 Direction	To E
N/A	X Walk 1 Width (in)	N/A	N/A	X Walk 2 Width (in)	N/A
	X Walk 1 Slope (%)	5.2		X Walk 2 Slope (%)	0.2
	X Walk 1 X Slope (%)	0.6		X Walk 2 X Slope (%)	5.9

N/A	Ramp inside XWalk1?	N/A	N/A	Ramp inside XWalk2?	N/A
	Road Slope (%)	4.0	N/A	Clear Space?	N/A
	Road X Slope (%)	3.6	N/A	Clear Space to XWalk (in)	N/A
N/A	Any Obstructions?	N/A	N/A	Storm Grate/Utility Hazard?	N/A
	Obstruction Type			Storm Grate/Utility Type	
		N/A			N/A
			Yes	Surface Condition? (G/P)	Good

Remove & Replace Curb Ramp With Two New Directional Ramps or Equivalent.
