Access Compliance Report

Public Rights-of-Way

(Curb Ramps)

Intersection ID: N/A	Main Street: E_STONEWALL_ST	Cross Street: MCDOWELL_ST	Location: E
ADA ID: 559EDB50D7FB	Ramp Type: Perp	Initial Pass/Fail: Fail	Overall Compliance: No
Severity Score: 21.25			
Codes/Mitigation Info/Possible Solution		Field Measurements/Component Compliance

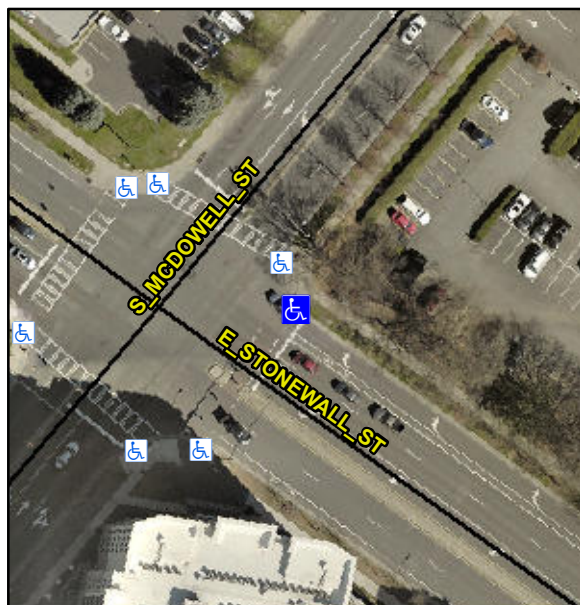
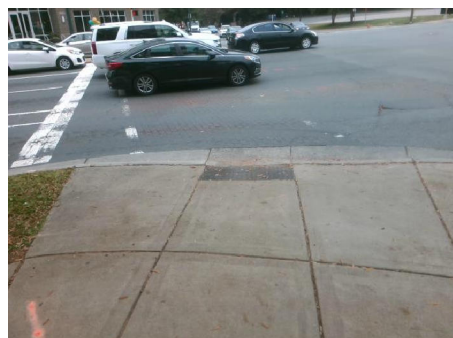
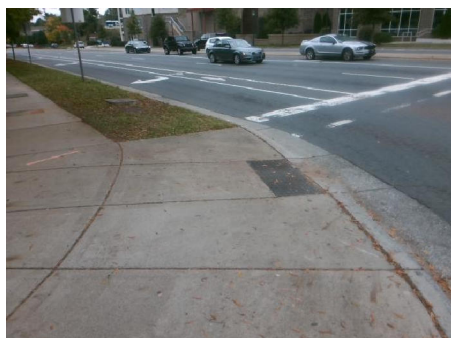
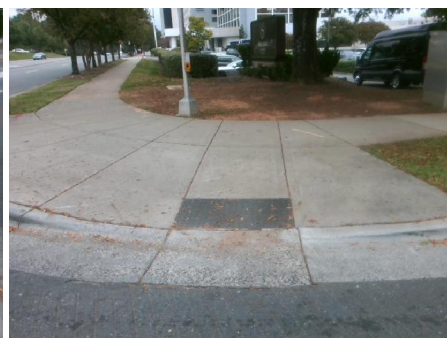
Not Found, R304.5.1, R304.2.2

Compliance	Description	Data	Compliance	Description	Data
N/A	Ramp Length (in)	94.0	No	Ramp Slope (%)	9.8
No	Ramp Width (in)	46.0	Yes	Ramp XSlope (%)	2.0
N/A	Flare Type LT	N/A	N/A	Flare Type RT	N/A
N/A	Flare Slope LT (%)	N/A	N/A	Flare Slope RT (%)	N/A
N/A	Flare Traversable LT?	N/A	N/A	Flare Traversable RT?	N/A
N/A	Landing Length (in)	N/A	N/A	DWS Provided?	N/A
N/A	Landing Width (in)	N/A	N/A	DWS Contrast?	N/A
N/A	Landing Slope (%)	N/A	N/A	DWS Length (in)	N/A
N/A	Landing X Slope (%)	N/A	N/A	DWS Full Width?	N/A
N/A	Landing Curb? (Y/N)	N/A	N/A	DWS Offset (in)	N/A
N/A	Shared Landing?	N/A			
N/A	Gutter Ponding?	N/A	N/A	Gutter Slope (%)	N/A
N/A	Gutter Lip Ht (in)	N/A	N/A	Gutter X Slope (%)	N/A
N/A	Painted X Walk1?	Yes	N/A	Painted X Walk2?	N/A
	X Walk 1 Direction	To SW		X Walk 2 Direction	N/A
N/A	X Walk 1 Width (in)	122.0	N/A	X Walk 2 Width (in)	N/A
	X Walk 1 Slope (%)	1.5		X Walk 2 Slope (%)	N/A
	X Walk 1 X Slope (%)	2.4		X Walk 2 X Slope (%)	N/A

N/A	Ramp inside XWalk1?	Yes	N/A	Ramp inside XWalk2?	N/A
	Road Slope (%)	N/A	N/A	Clear Space?	N/A
	Road X Slope (%)	N/A	N/A	Clear Space to XWalk (in)	N/A
N/A	Any Obstructions?	N/A	N/A	Storm Grate/Utility Hazard?	N/A
	Obstruction Type			Storm Grate/Utility Type	
		N/A			N/A
			Yes	Surface Condition? (G/P)	Good

Possible Solutions:

Remove & Replace Entire Ramp.

Total Cost: \$ 1850.00
