| Intersection ID: 21994 | | Main Street: CREEKBED_LN | | Cross Street: PARK_RD | | Location: | | NW | | | |
| ADA ID: 55A2F1A56200 | | Ramp Type: PerpDiag | | Initial Pass/Fail: Fail | | Overall Compliance: No | | Severity Score: 13.75 | | | |

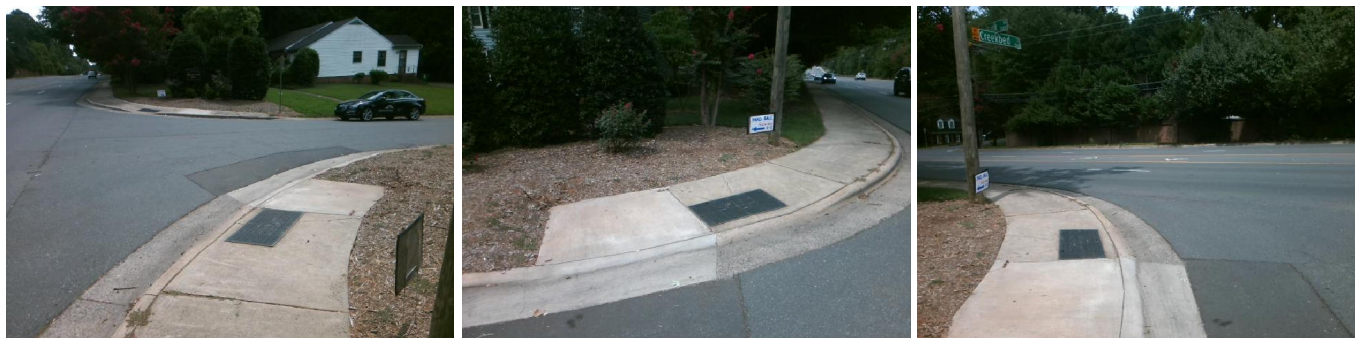
| | | <p>Possible Solutions:</p> <p>Remove & Replace Curb Ramp With Two New Directional Ramps or Equivalent.</p> <p>Surveyor Notes:</p> <p>N/A</p> <p>PROW/ADA:</p> <p>Not Found, R304.2.2, R304.5.3</p> | | Compliance | | Description | | Data | | | |
