Access Compliance Report

Public Rights-of-Way

(Curb Ramps)

Intersection ID: 46758	Main Street: CUMBERLAND_COVE_DR	Cross Street: SUPERIOR_ST	Location: NW
ADA ID: 55B8F0352ED8	Ramp Type: PerpDiag	Initial Pass/Fail: Fail	Overall Compliance: No
Codes/Mitigation Info/Possible Solution		Field Measurements/Component Compliance

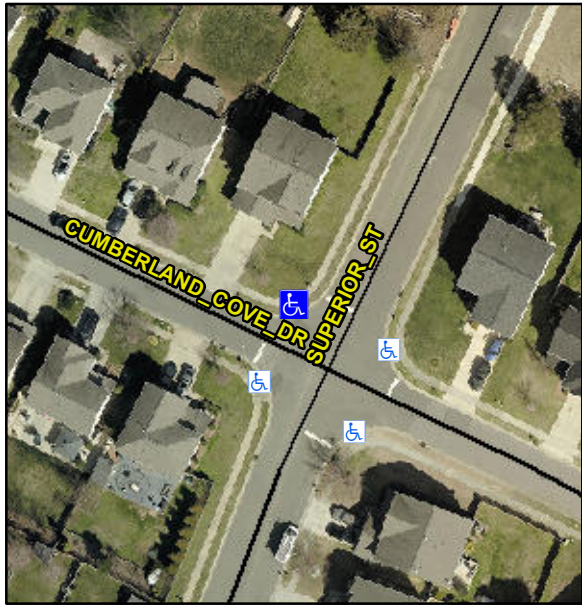
Possible Solutions:		Compliance		Description	Data	Compliance	Description	Data
	Remove & Replace Curb Ramp With Two New Directional Ramps or Equivalent.		N/A	Ramp Length (in)	47.0	No	Ramp Slope (%)	10.3	
			Yes	Ramp Width (in)	48.0	No	Ramp XSlope (%)	3.4	
			N/A	Flare Type LT	N/A	N/A	Flare Type RT	N/A	
			N/A	Flare Slope LT (%)	N/A	N/A	Flare Slope RT (%)	N/A	
			N/A	Flare Traversable LT?	N/A	N/A	Flare Traversable RT?	N/A	
			N/A	Landing Length (in)	N/A	N/A	DWS Provided?	N/A	
			N/A	Landing Width (in)	N/A	N/A	DWS Contrast?	N/A	
			N/A	Landing Slope (%)	N/A	N/A	DWS Length (in)	N/A	
			N/A	Landing X Slope (%)	N/A	N/A	DWS Full Width?	N/A	
Surveyor Notes:		N/A	N/A	Landing Curb? (Y/N)	N/A	N/A	DWS Offset (in)	N/A	
			N/A	Shared Landing?	N/A				
PROW/ADA:			N/A	Gutter Ponding?	N/A	N/A	Gutter Slope (%)	N/A	
			N/A	Gutter Lip Ht (in)	N/A	N/A	Gutter X Slope (%)	N/A	
			N/A	Painted X Walk1?	No	N/A	Painted X Walk2?	No

X Walk 1 Direction	To SW		X Walk 2 Direction	To SE	
			N/A	X Walk 1 Width (in)	N/A	N/A	X Walk 2 Width (in)	N/A	
				X Walk 1 Slope (%)	4.0		X Walk 2 Slope (%)	0.9	
				X Walk 1 X Slope (%)	2.4		X Walk 2 X Slope (%)	3.9	
			N/A	Ramp inside XWalk1?	N/A	N/A	Ramp inside XWalk2?	N/A	
				Road Slope (%)	2.9	N/A	Clear Space?	N/A	
				Road X Slope (%)	4.5	N/A	Clear Space to XWalk (in)	N/A	
			N/A	Any Obstructions?	N/A	N/A	Storm Grate/Utility Hazard?	N/A	
				Obstruction Type			Storm Grate/Utility Type		
					N/A			N/A	
						Yes	Surface Condition? (G/P)	Good

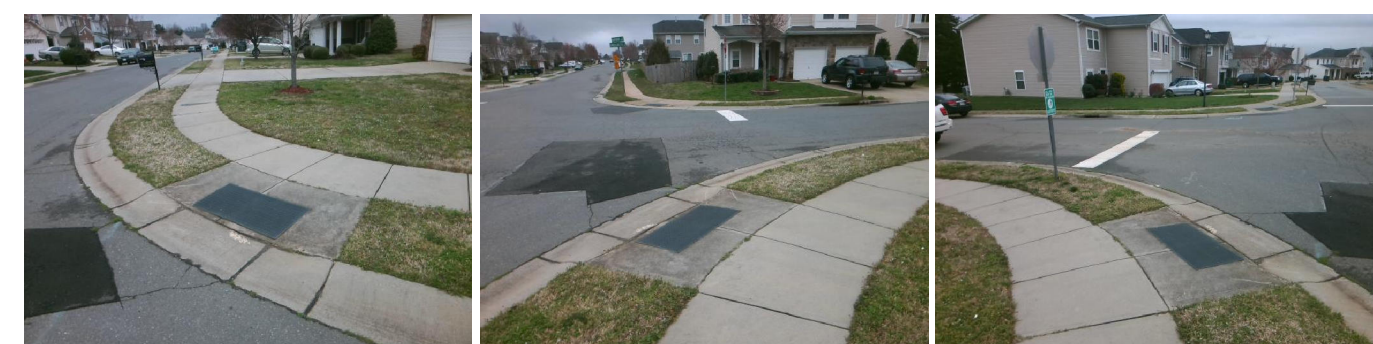
Compliance	Description	Data	Compliance	Description	Data
N/A	Ramp Length (in)	47.0	No	Ramp Slope (%)	10.3
Yes	Ramp Width (in)	48.0	No	Ramp XSlope (%)	3.4
N/A	Flare Type LT	N/A	N/A	Flare Type RT	N/A
N/A	Flare Slope LT (%)	N/A	N/A	Flare Slope RT (%)	N/A
N/A	Flare Traversable LT?	N/A	N/A	Flare Traversable RT?	N/A
N/A	Landing Length (in)	N/A	N/A	DWS Provided?	N/A
N/A	Landing Width (in)	N/A	N/A	DWS Contrast?	N/A
N/A	Landing Slope (%)	N/A	N/A	DWS Length (in)	N/A
N/A	Landing X Slope (%)	N/A	N/A	DWS Full Width?	N/A
N/A	Landing Curb? (Y/N)	N/A	N/A	DWS Offset (in)	N/A
N/A	Shared Landing?	N/A			
N/A	Gutter Ponding?	N/A	N/A	Gutter Slope (%)	N/A
N/A	Gutter Lip Ht (in)	N/A	N/A	Gutter X Slope (%)	N/A
N/A	Painted X Walk1?	No	N/A	Painted X Walk2?	No
	X Walk 1 Direction	To SW		X Walk 2 Direction	To SE
N/A	X Walk 1 Width (in)	N/A	N/A	X Walk 2 Width (in)	N/A
	X Walk 1 Slope (%)	4.0		X Walk 2 Slope (%)	0.9
	X Walk 1 X Slope (%)	2.4		X Walk 2 X Slope (%)	3.9

N/A	Ramp inside XWalk1?	N/A	N/A	Ramp inside XWalk2?	N/A
	Road Slope (%)	2.9	N/A	Clear Space?	N/A
	Road X Slope (%)	4.5	N/A	Clear Space to XWalk (in)	N/A
N/A	Any Obstructions?	N/A	N/A	Storm Grate/Utility Hazard?	N/A
	Obstruction Type			Storm Grate/Utility Type	
		N/A			N/A
			Yes	Surface Condition? (G/P)	Good
