# Access Compliance Report

## Public Rights-of-Way

### (Curb Ramps)

Intersection ID: 9847	Main Street: BLACKWOOD_AV	Cross Street: THE_PLAZA	Location: SW
ADA ID: 55BC09DC73F3	Ramp Type: PerpDiag	Initial Pass/Fail: Fail	Overall Compliance: No
Severity Score: 22.5			
Codes/Mitigation Info/Possible Solution		Field Measurements/Component Compliance

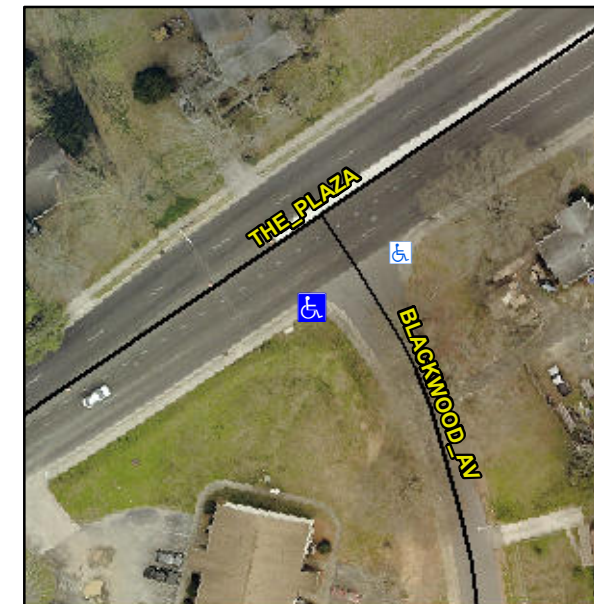
**Not Found, R304.5.1, R304.2.2, R304.5.3**

Compliance	Description	Data	Compliance	Description	Data
N/A	Ramp Length (in)	59.5	No	Ramp Slope (%)	10.1
No	Ramp Width (in)	43.0	No	Ramp XSlope (%)	3.2
N/A	Flare Type LT	N/A	N/A	Flare Type RT	N/A
N/A	Flare Slope LT (%)	N/A	N/A	Flare Slope RT (%)	N/A
N/A	Flare Traversable LT?	N/A	N/A	Flare Traversable RT?	N/A
N/A	Landing Length (in)	N/A	N/A	DWS Provided?	N/A
N/A	Landing Width (in)	N/A	N/A	DWS Contrast?	N/A
N/A	Landing Slope (%)	N/A	N/A	DWS Length (in)	N/A
N/A	Landing X Slope (%)	N/A	N/A	DWS Full Width?	N/A
N/A	Landing Curb? (Y/N)	N/A	N/A	DWS Offset (in)	N/A
N/A	Shared Landing?	N/A			
N/A	Gutter Ponding?	N/A	N/A	Gutter Slope (%)	N/A
N/A	Gutter Lip Ht (in)	N/A	N/A	Gutter X Slope (%)	N/A
N/A	Painted X Walk1?	No	N/A	Painted X Walk2?	No
	X Walk 1 Direction	To NE		X Walk 2 Direction	To NW
N/A	X Walk 1 Width (in)	N/A	N/A	X Walk 2 Width (in)	N/A
	X Walk 1 Slope (%)	2.1		X Walk 2 Slope (%)	2.7
	X Walk 1 X Slope (%)	2.9		X Walk 2 X Slope (%)	0.6

N/A	Ramp inside XWalk1?	N/A	N/A	Ramp inside XWalk2?	N/A
	Road Slope (%)	3.6	N/A	Clear Space?	N/A
	Road X Slope (%)	0.2	N/A	Clear Space to XWalk (in)	N/A
N/A	Any Obstructions?	N/A	N/A	Storm Grate/Utility Hazard?	N/A
	Obstruction Type			Storm Grate/Utility Type	
		N/A			N/A
			Yes	Surface Condition? (G/P)	Good

**Remove & Replace Curb Ramp With Two New Directional Ramps or Equivalent.**
