# Access Compliance Report

## Public Rights-of-Way

### (Curb Ramps)

Intersection ID: 12589	Main Street: BELVEDERE_AV	Cross Street: TRUMAN_RD	Location: SW
ADA ID: 55C419C16883	Ramp Type: PerpDiag	Initial Pass/Fail: Fail	Overall Compliance: No
Codes/Mitigation Info/Possible Solution		Field Measurements/Component Compliance	
Severity Score: 8.75

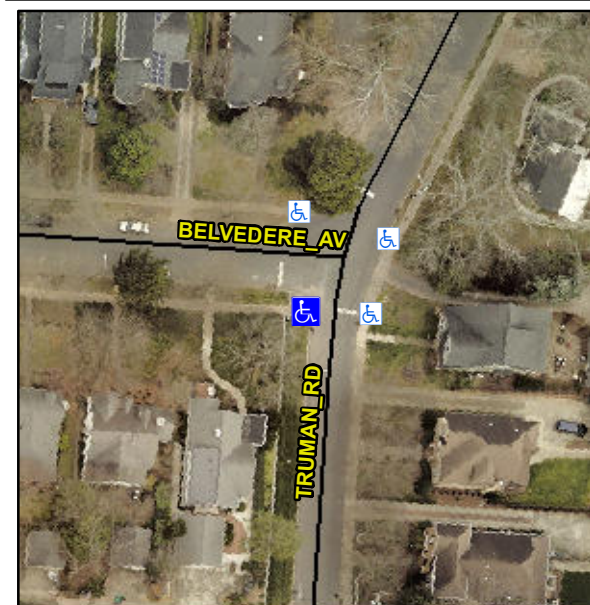
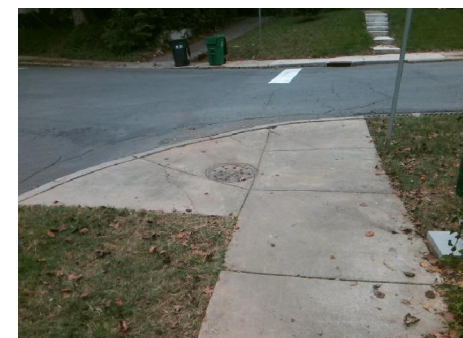
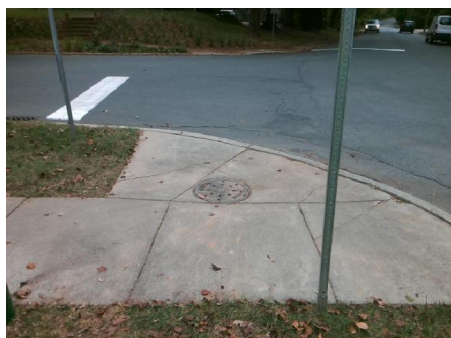
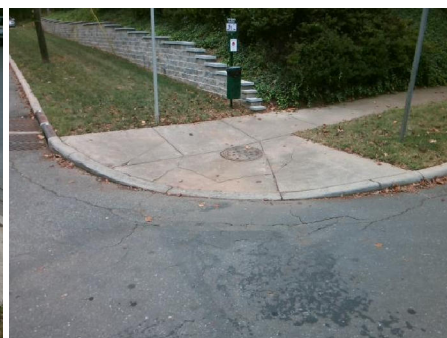
**Not Found, R304.5.1**

Compliance	Description	Data	Compliance	Description	Data
N/A	Ramp Length (in)	49.0	Yes	Ramp Slope (%)	6.0
No	Ramp Width (in)	43.0	Yes	Ramp XSlope (%)	0.8
N/A	Flare Type LT	N/A	N/A	Flare Type RT	N/A
N/A	Flare Slope LT (%)	N/A	N/A	Flare Slope RT (%)	N/A
N/A	Flare Traversable LT?	N/A	N/A	Flare Traversable RT?	N/A
N/A	Landing Length (in)	N/A	N/A	DWS Provided?	N/A
N/A	Landing Width (in)	N/A	N/A	DWS Contrast?	N/A
N/A	Landing Slope (%)	N/A	N/A	DWS Length (in)	N/A
N/A	Landing X Slope (%)	N/A	N/A	DWS Full Width?	N/A
N/A	Landing Curb? (Y/N)	N/A	N/A	DWS Offset (in)	N/A
N/A	Shared Landing?	N/A			
N/A	Gutter Ponding?	N/A	N/A	Gutter Slope (%)	N/A
N/A	Gutter Lip Ht (in)	N/A	N/A	Gutter X Slope (%)	N/A
N/A	Painted X Walk1?	No	N/A	Painted X Walk2?	No
	X Walk 1 Direction	To E		X Walk 2 Direction	To N
N/A	X Walk 1 Width (in)	N/A	N/A	X Walk 2 Width (in)	N/A
	X Walk 1 Slope (%)	0.1		X Walk 2 Slope (%)	3.9
	X Walk 1 X Slope (%)	0.6		X Walk 2 X Slope (%)	2.1

N/A	Ramp inside XWalk1?	N/A	N/A	Ramp inside XWalk2?	N/A
	Road Slope (%)	0.9	N/A	Clear Space?	N/A
	Road X Slope (%)	0.3	N/A	Clear Space to XWalk (in)	N/A
N/A	Any Obstructions?	N/A	N/A	Storm Grate/Utility Hazard?	N/A
	Obstruction Type			Storm Grate/Utility Type	
		N/A			N/A
			Yes	Surface Condition? (G/P)	Good

**Remove & Replace Curb Ramp With Two New Directional Ramps or Equivalent.**
