Access Compliance Report Public Rights-of-Way (Curb Ramps)

Intersection ID: 18011	Main St	reet: PARK_RD	Cross Street: HEATHER LN					Location:	SE
ADA ID: 55D4C2EEB4FB	Ramp Type: Perp			Initial Pass/Fail: Fail Overall Compliance: No					12.5

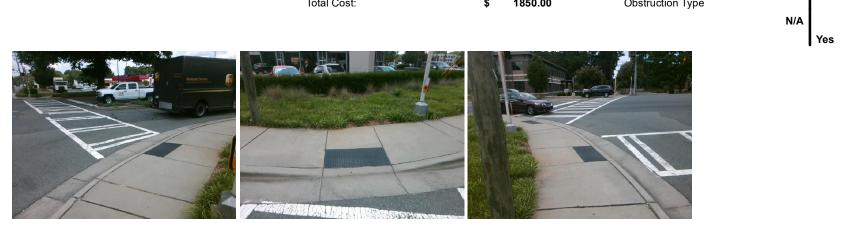
12.5
Codes/Mitigation Info/Possible Solution			Field Measurements/Component Compliance						
		Possible Solutions:	Compliance Description			Data Compliance Description			Data
	R	Remove & Replace Entire Ramp	. N/A	Ramp Le	ength (in)	72.0	No	Ramp Slope (%)	8.8
			Yes	Ramp W	/idth (in)	48.0	Yes	Ramp XSlope (%)	0.6
	140-		N/A	Flare Ty	pe LT	N/A	N/A	Flare Type RT	N/A
mild.	C. N. A.		N/A	Flare SI	ope LT (%)	N/A	N/A	Flare Slope RT (%)	N/A
BARK RD COM	1 5	7	N/A	Flare Tra	aversable LT?	N/A	N/A	Flare Traversable RT?	N/A
HEATIHER LIN SHOPPI	NG_CENTER_DR		N/A	Landing	Length (in)	N/A	N/A	DWS Provided?	N/A
		Surveyor Notes:	N/A	Landing	Width (in)	N/A	N/A	DWS Contrast?	N/A
et and the second		N/A	N/A	Landing	Slope (%)	N/A	N/A	DWS Length (in)	N/A
B & CAR			N/A	Landing	X Slope (%)	N/A	N/A	DWS Full Width?	N/A
			N/A	Landing	Curb? (Y/N)	N/A	N/A	DWS Offset (in)	N/A
			N/A	Shared I	Landing?	N/A			
	PROW/ADA:	N/A	Gutter F	onding?	N/A	N/A	Gutter Slope (%)	N/A

Not Found, R304.2.2	N/A	Gutter L	ip Ht (in)	N/A	N/A	Gutter X Slope (%)	N/A
	-		N/A	Painted	X Walk1?	Yes	N/A	Painted X Walk2?	N/A
			X Walk ²	1 Direction	To N		X Walk 2 Direction	N/A	
			N/A	X Walk ²	1 Width (in)	107.0	N/A	X Walk 2 Width (in)	N/A
Street 1 Name	HEATHER LN	-			1 Slope (%)	2.7		X Walk 2 Slope (%)	N/A
Stop Condition-Street 2	Signal				1 X Slope (%)	3.5		X Walk 2 X Slope (%)	N/A
Street 2 Name	N/A		N/A		side XWalk1?	Yes	N/A	Ramp inside XWalk2?	N/A
Stop Condition-Street 1	N/A			Road Sl		N/A	N/A	Clear Space?	N/A
					Slope (%)	N/A	N/A	Clear Space to XWalk (in)	N/A
			N/A		structions?	N/A	N/A	Storm Grate/Utility Hazard?	N/A
		Total Cost: \$	1850.00	•	tion Type	N/A		Storm Grate/Utility Type	11/2
			1000.00	Obstruc	ион туре	N1/A		Storm Grate/Otility Type	
						N/A			N/A

Good
