Access Compliance Report

Public Rights-of-Way

(Curb Ramps)

Intersection ID: 48866	Main Street: GRASSLANDS_CT	Cross Street: ERWIN_RD	Location: NW
ADA ID: 55D68E4128A6	Ramp Type: Perp	Initial Pass/Fail: Fail	Overall Compliance: No Severity Score: 13.75

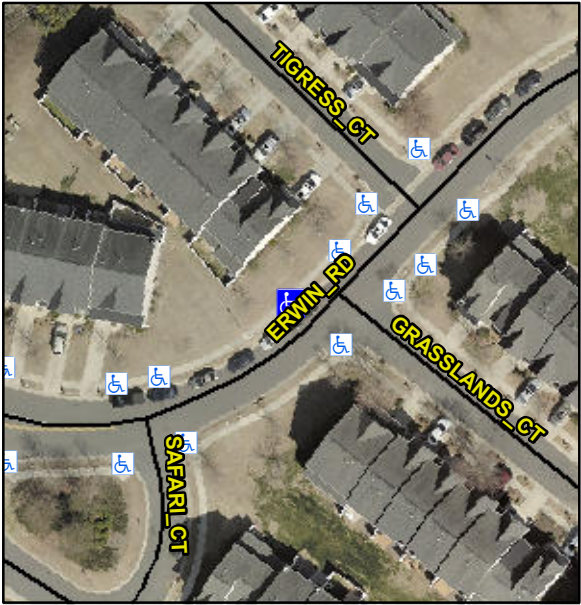
Possible Solutions:		Compliance	Description	Data
	Remove & Replace Entire Ramp.		No	Ramp Length (in)	47.0
			Yes	Ramp Width (in)	48.0
			N/A	Flare Type LT	N/A
			N/A	Flare Slope LT (%)	N/A
			N/A	Flare Traversable LT?	N/A
			N/A	Landing Length (in)	N/A
			N/A	Landing Width (in)	N/A
			N/A	Landing Slope (%)	N/A
			N/A	Landing X Slope (%)	N/A
<p>Surveyor Notes:</p> <p>N/A</p> <p>PROW/ADA:</p> <p>Not Found, R304.2.2</p>			N/A	Flare Type RT	N/A
			N/A	Flare Slope RT (%)	N/A
			N/A	Flare Traversable RT?	N/A
			N/A	DWS Provided?	N/A
			N/A	DWS Contrast?	N/A
			N/A	DWS Length (in)	N/A
			N/A	DWS Full Width?	N/A
			N/A	DWS Offset (in)	N/A
			N/A	Gutter Ponding?	N/A
			N/A	Gutter Lip Ht (in)	N/A
			No	Painted X Walk1?	N/A
				X Walk 1 Direction	To S
			N/A	X Walk 1 Width (in)	N/A
				X Walk 1 Slope (%)	4.4
				X Walk 1 X Slope (%)	3.3
			N/A	Ramp inside XWalk1?	N/A

N/A	Road Slope (%)	N/A
			N/A	Road X Slope (%)	N/A
			N/A	Any Obstructions?	N/A
				Obstruction Type	
Total Cost:		\$ 1850.00	N/A	Clear Space?	N/A
			N/A	Clear Space to XWalk (in)	N/A
			N/A	Storm Grate/Utility Hazard?	N/A
				Storm Grate/Utility Type	
			Yes	Surface Condition? (G/P)	Good
