Access Compliance Report

Public Rights-of-Way

(Curb Ramps)

Intersection ID: 23225	Main Street: CARMEL_RD	Cross Street: HILLINGDON_RD	Location: N
ADA ID: 55E4E99DDB8C	Ramp Type: PerpDiag	Initial Pass/Fail: Fail	Overall Compliance: No
			Severity Score: 13.75

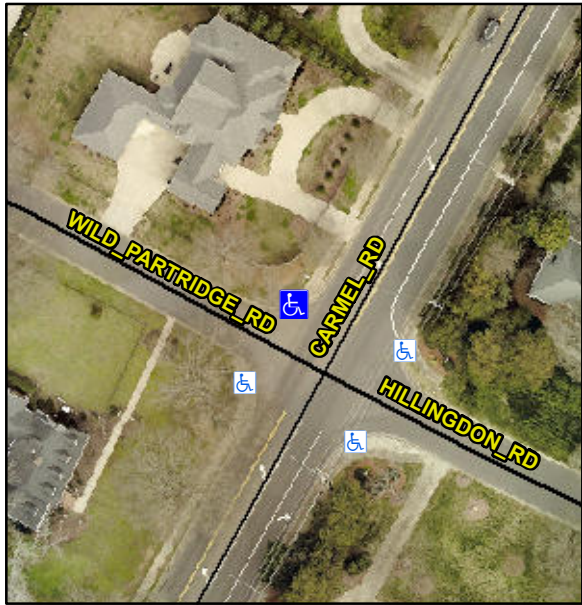
<div>Street 1 Name<div>HILLINGTON RD</div></div> <div>Stop Condition-Street 2<div>StopSign</div></div> <div>Street 2 Name<div>CARMEL RD</div></div> <div>Stop Condition-Street 1<div>None</div></div>	Possible Solutions:		Compliance	Description	Data	Compliance	Description	Data
	Remove & Replace Curb Ramp With Two New Directional Ramps or Equivalent.		N/A	Ramp Length (in)	81.0	No	Ramp Slope (%)	10.0
			Yes	Ramp Width (in)	48.0	No	Ramp XSlope (%)	4.1
			N/A	Flare Type LT	N/A	N/A	Flare Type RT	N/A
			N/A	Flare Slope LT (%)	N/A	N/A	Flare Slope RT (%)	N/A
			N/A	Flare Traversable LT?	N/A	N/A	Flare Traversable RT?	N/A
			N/A	Landing Length (in)	N/A	N/A	DWS Provided?	N/A
			N/A	Landing Width (in)	N/A	N/A	DWS Contrast?	N/A
			N/A	Landing Slope (%)	N/A	N/A	DWS Length (in)	N/A
			N/A	Landing X Slope (%)	N/A	N/A	DWS Full Width?	N/A

Surveyor Notes: <div>N/A</div>			N/A	Landing Curb? (Y/N)	N/A	N/A	DWS Offset (in)	N/A
			N/A	Shared Landing?	N/A			
			N/A	Gutter Ponding?	N/A	N/A	Gutter Slope (%)	N/A
			N/A	Gutter Lip Ht (in)	N/A	N/A	Gutter X Slope (%)	N/A
			N/A	Painted X Walk1?	No	N/A	Painted X Walk2?	No
				X Walk 1 Direction	To SW		X Walk 2 Direction	To SE
			N/A	X Walk 1 Width (in)	N/A	N/A	X Walk 2 Width (in)	N/A
				X Walk 1 Slope (%)	1.2		X Walk 2 Slope (%)	3.8
				X Walk 1 X Slope (%)	2.5		X Walk 2 X Slope (%)	0.1
			N/A	Ramp inside XWalk1?	N/A	N/A	Ramp inside XWalk2?	N/A
PROW/ADA: <div>Not Found, R304.2.2, R304.5.3</div>				Road Slope (%)	0.2	N/A	Clear Space?	N/A
				Road X Slope (%)	0.6	N/A	Clear Space to XWalk (in)	N/A
			N/A	Any Obstructions?	N/A	N/A	Storm Grate/Utility Hazard?	N/A
				Obstruction Type			Storm Grate/Utility Type	
					N/A			N/A
						Yes	Surface Condition? (G/P)	Good
	Total Cost:		\$	3200.00
