Access Compliance Report

Public Rights-of-Way

(Curb Ramps)

Intersection ID: 44482	Main Street: AINSWORTH_ST	Cross Street: REDDING_GLEN_AV	Location: SE
ADA ID: 55E6DD3ED3EC	Ramp Type: BlendTrans1	Initial Pass/Fail: Fail	Overall Compliance: No
		Severity Score: 10

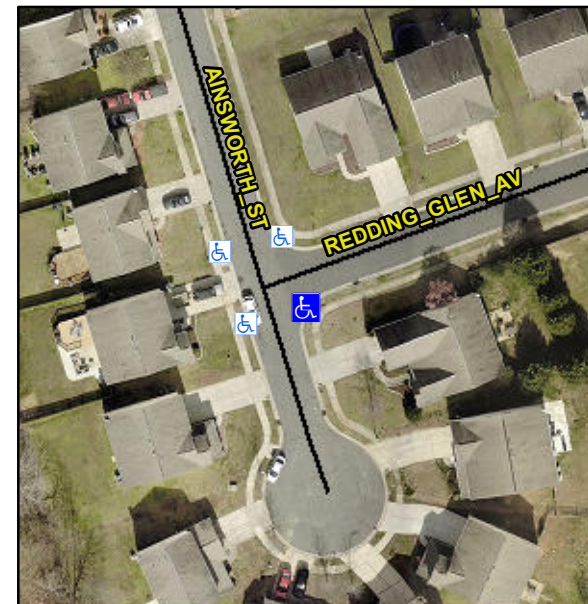
Not Found, R304.5.1, R304.5.3

Compliance	Description	Data	Compliance	Description	Data
N/A	Ramp Length (in)	46.5	Yes	BlendTrans Slope (%)	3.8
No	Ramp Width (in)	47.0	No	BlendTrans XSlope (%)	3.9
N/A	Flare Type LT	N/A	N/A	Flare Type RT	N/A
N/A	Flare Slope LT (%)	N/A	N/A	Flare Slope RT (%)	N/A
N/A	Flare Traversable LT?	N/A	N/A	Flare Traversable RT?	N/A
N/A	Landing Length (in)	N/A	N/A	DWS Provided?	N/A
N/A	Landing Width (in)	N/A	N/A	DWS Contrast?	N/A
N/A	Landing Slope (%)	N/A	N/A	DWS Length (in)	N/A
N/A	Landing X Slope (%)	N/A	N/A	DWS Full Width?	N/A
N/A	Landing Curb? (Y/N)	N/A	N/A	DWS Offset (in)	N/A
N/A	Shared Landing?	N/A			
N/A	Gutter Ponding?	N/A	N/A	Gutter Slope (%)	N/A
N/A	Gutter Lip Ht (in)	N/A	N/A	Gutter X Slope (%)	N/A
N/A	Painted X Walk1?	No	N/A	Painted X Walk2?	No
	X Walk 1 Direction	To N		X Walk 2 Direction	To W
	X Walk 1 Width (in)	N/A		X Walk 2 Width (in)	N/A
	X Walk 1 Slope (%)	4.2		X Walk 2 Slope (%)	2.8
	X Walk 1 X Slope (%)	0.3		X Walk 2 X Slope (%)	3.3

N/A	Ramp inside XWalk1?	N/A	N/A	Ramp inside XWalk2?	N/A
	Road Slope (%)	3.3		Clear Space?	N/A
	Road X Slope (%)	5.5	N/A	Clear Space to XWalk (in)	N/A
N/A	Any Obstructions?	N/A	N/A	Storm Grate/Utility Hazard?	N/A
	Obstruction Type			Storm Grate/Utility Type	
		N/A			N/A
			Yes	Surface Condition? (G/P)	Good
			No	Curb Slope (%)	13.1

Possible Solutions:

Remove & Replace Curb Ramp With Two New Directional Ramps or Equivalent.
