Access Compliance Report

Public Rights-of-Way

(Curb Ramps)

Intersection ID: 51356	Main Street: BRENTMOOR_DR	Cross Street: PEARL_ST	Location:	E
ADA ID: 55E936ABFD84	Ramp Type: Combination2	Initial Pass/Fail: Pass	Overall Compliance: No	Severity Score: 0.25

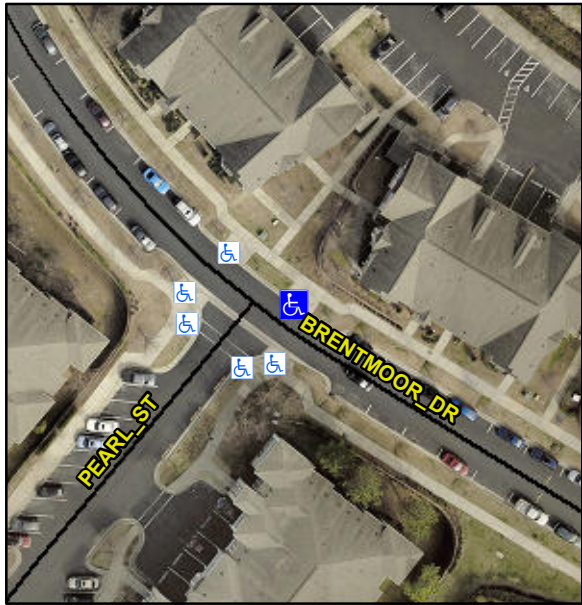
Possible Solutions:		Compliance			Description			Data	Compliance			Description			Data
	Remove & Replace Entire Ramp.		N/A	Ramp Length LT (in)			N/A	Ramp Length RT (in)			72.0					
	Remove & Replace Gutter.		N/A	Ramp Width LT (in)			N/A	Ramp Width RT (in)			60.0					
			N/A	Ramp Slope LT (%)			N/A	Ramp Slope RT (%)			7.3					
			N/A	Ramp XSlope LT (%)			N/A	Ramp XSlope RT (%)			4.8					
			N/A	Ramp Length (in)			85.0	Ramp Slope (%)			5.1					
			Yes	Ramp Width (in)			59.0	Ramp XSlope (%)			3.6					
			N/A	Flare Type LT			Sloped	Flare Type RT			Sloped					
			Yes	Flare Slope LT (%)			2.7	Flare Slope RT (%)			6.9					
			N/A	Flare Traversable LT?			Yes	Flare Traversable RT?			Yes					
Surveyor Notes: N/A			Yes	Landing Length (in)			72.0	DWS Provided?			Yes					
			Yes	Landing Width (in)			60.0	DWS Contrast?			Yes

No	Landing Slope (%)			3.0	DWS Length (in)			24.5					
			Yes	Landing X Slope (%)			1.1	DWS Full Width?			Yes					
			N/A	Landing Curb? (Y/N)			No	DWS Offset (in)			1.0					
			N/A	Shared Landing?			No									
			Yes	Gutter Ponding?			No	Gutter Slope (%)			2.3					
			Yes	Gutter Lip Ht (in)			0.0	Gutter X Slope (%)			4.1					
			N/A	Painted X Walk1?			No	Painted X Walk2?			N/A					
				X Walk 1 Direction			To SW	X Walk 2 Direction			N/A					
PROW/ADA: Not Found, R304.5.3, R304.2.2-Perp, R304.3.2-Para				X Walk 1 Width (in)			N/A	X Walk 2 Width (in)			N/A					
				X Walk 1 Slope (%)			3.1	X Walk 2 Slope (%)			N/A					
				X Walk 1 X Slope (%)			1.2	X Walk 2 X Slope (%)			N/A					
			N/A	Ramp inside XWalk1?			N/A	Ramp inside XWalk2?			N/A					
				Road Slope (%)			N/A	Clear Space?			Yes					
				Road X Slope (%)			N/A	Clear Space to XWalk (in)			N/A					
								Yes			Any Obstruction?	No				
											Obstruction Type	N/A

Yes	Storm Grate/Utility Hazard?			No	Storm Grate/Utility Type			N/A					
			Yes	Surface Condition? (G/P)			Good	Curb Slope (%)			24.6					
Street 1 Name			None													
Stop Condition-Street 1			BRENTMOOR DR													
Street 2 Name			N/A													
Stop Condition-Street 2			N/A													
Total Cost:			\$ 2350.00
