# Access Compliance Report

## Public Rights-of-Way

### (Curb Ramps)

Intersection ID: 23447	Main Street: BRACKENBURY_LN	Cross Street: ALEXANDER_RD	Location: SW
ADA ID: 55F07BA1B7A9	Ramp Type: Perp	Initial Pass/Fail: Fail	Overall Compliance: No
		Severity Score: 8.75

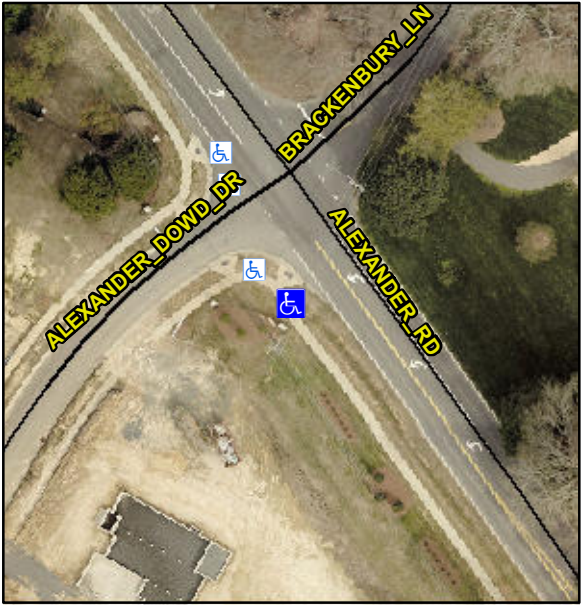
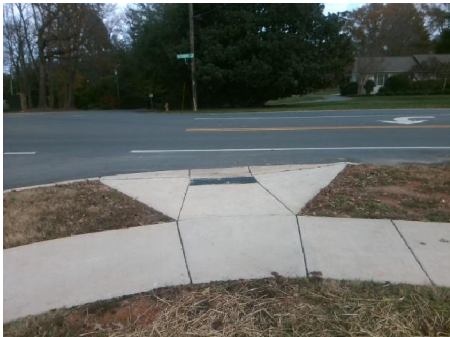
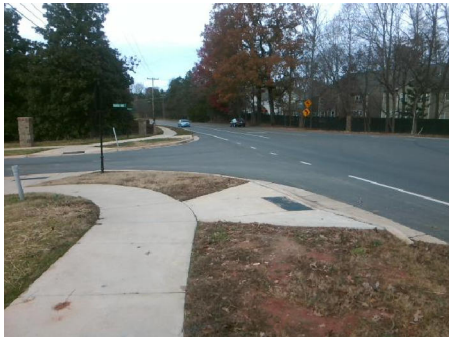
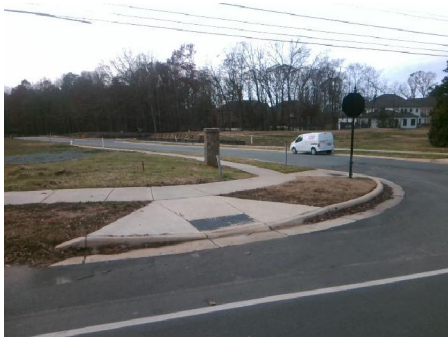
Compliance	Description	Data	Compliance	Description	Data
N/A	Ramp Length (in)	29.0	Yes	Ramp Slope (%)	5.2
No	Ramp Width (in)	46.5	Yes	Ramp XSlope (%)	1.8
N/A	Flare Type LT	N/A	N/A	Flare Type RT	N/A
N/A	Flare Slope LT (%)	N/A	N/A	Flare Slope RT (%)	N/A
N/A	Flare Traversable LT?	N/A	N/A	Flare Traversable RT?	N/A
N/A	Landing Length (in)	N/A	N/A	DWS Provided?	N/A
N/A	Landing Width (in)	N/A	N/A	DWS Contrast?	N/A
N/A	Landing Slope (%)	N/A	N/A	DWS Length (in)	N/A
N/A	Landing X Slope (%)	N/A	N/A	DWS Full Width?	N/A
N/A	Landing Curb? (Y/N)	N/A	N/A	DWS Offset (in)	N/A
N/A	Shared Landing?	N/A			
N/A	Gutter Ponding?	N/A	N/A	Gutter Slope (%)	N/A
N/A	Gutter Lip Ht (in)	N/A	N/A	Gutter X Slope (%)	N/A
N/A	Painted X Walk1?	No	N/A	Painted X Walk2?	N/A
	X Walk 1 Direction	To NE		X Walk 2 Direction	N/A
N/A	X Walk 1 Width (in)	N/A	N/A	X Walk 2 Width (in)	N/A
	X Walk 1 Slope (%)	3.6		X Walk 2 Slope (%)	N/A
	X Walk 1 X Slope (%)	2.4		X Walk 2 X Slope (%)	N/A

N/A	Ramp inside XWalk1?	N/A	N/A	Ramp inside XWalk2?	N/A
	Road Slope (%)	N/A	N/A	Clear Space?	N/A
	Road X Slope (%)	N/A	N/A	Clear Space to XWalk (in)	N/A
N/A	Any Obstructions?	N/A	N/A	Storm Grate/Utility Hazard?	N/A
	Obstruction Type			Storm Grate/Utility Type	
		N/A			N/A
			Yes	Surface Condition? (G/P)	Good

Possible Solutions:				
	Remove & Replace Entire Ramp.				
	Surveyor Notes:				
	N/A				
	PROW/ADA:				
	R304.5.1				
Street 1 Name	ALEXANDER RD				
Stop Condition-Street 2	None				
Street 2 Name	N/A				
Stop Condition-Street 1	N/A				
Total Cost:		\$	1850.00
