Access Compliance Report

Public Rights-of-Way

(Curb Ramps)

Intersection ID: 26586	Main Street: ARBORHILL_RD	Cross Street: WINTHROP_RIDGE_RD	Location: W
ADA ID: 55FDAF285DC4	Ramp Type: Perp	Initial Pass/Fail: Fail	Overall Compliance: No
		Severity Score: 12.5

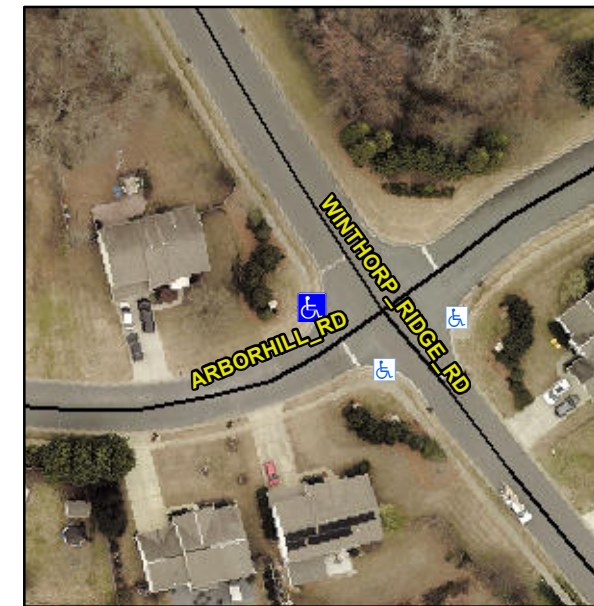
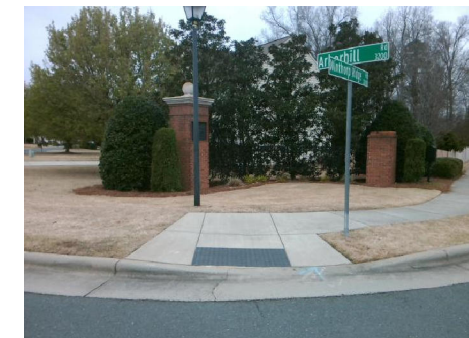
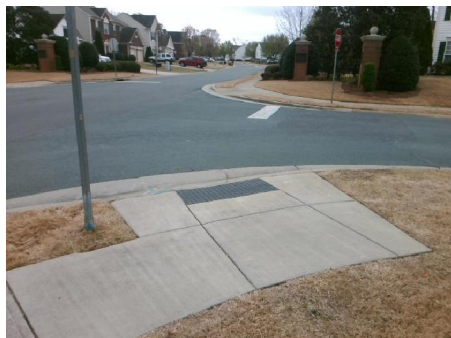
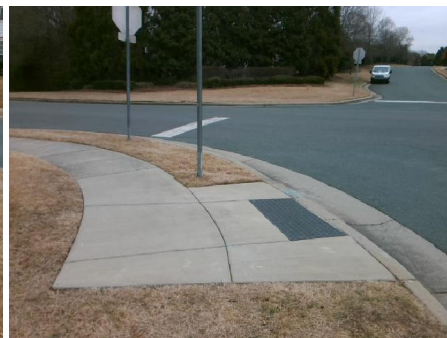
Not Found, R304.5.3

Compliance	Description	Data	Compliance	Description	Data
N/A	Ramp Length (in)	48.0	Yes	Ramp Slope (%)	6.3
Yes	Ramp Width (in)	48.0	No	Ramp XSlope (%)	6.1
N/A	Flare Type LT	N/A	N/A	Flare Type RT	N/A
N/A	Flare Slope LT (%)	N/A	N/A	Flare Slope RT (%)	N/A
N/A	Flare Traversable LT?	N/A	N/A	Flare Traversable RT?	N/A
N/A	Landing Length (in)	N/A	N/A	DWS Provided?	N/A
N/A	Landing Width (in)	N/A	N/A	DWS Contrast?	N/A
N/A	Landing Slope (%)	N/A	N/A	DWS Length (in)	N/A
N/A	Landing X Slope (%)	N/A	N/A	DWS Full Width?	N/A
N/A	Landing Curb? (Y/N)	N/A	N/A	DWS Offset (in)	N/A
N/A	Shared Landing?	N/A			
N/A	Gutter Ponding?	N/A	N/A	Gutter Slope (%)	N/A
N/A	Gutter Lip Ht (in)	N/A	N/A	Gutter X Slope (%)	N/A
N/A	Painted X Walk1?	No	N/A	Painted X Walk2?	N/A
	X Walk 1 Direction	To SE		X Walk 2 Direction	N/A
N/A	X Walk 1 Width (in)	N/A	N/A	X Walk 2 Width (in)	N/A
	X Walk 1 Slope (%)	3.0		X Walk 2 Slope (%)	N/A
	X Walk 1 X Slope (%)	0.7		X Walk 2 X Slope (%)	N/A

Possible Solutions:

Remove & Replace Entire Ramp.

Total Cost: \$ 1850.00
