# Access Compliance Report

## Public Rights-of-Way

### (Curb Ramps)

Intersection ID: N/A	Main Street: PERWINKLE_HILL_CT	Cross Street: N/A	Location: E
ADA ID: 5603DF3808D6	Ramp Type: PerpDiag	Initial Pass/Fail: Pass	Overall Compliance: No
Severity Score: 15.25			
Codes/Mitigation Info/Possible Solution		Field Measurements/Component Compliance

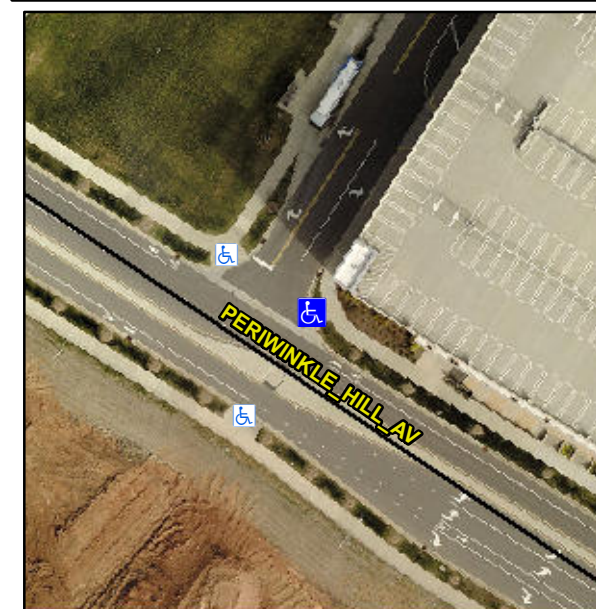
PROW/ADA:

**Not Found, R304.5.3, R304.2.1, R304.2.2-Perp, R304.3.2-Para, R302.7.2**

Compliance	Description	Data	Compliance	Description	Data
N/A	Ramp Length (in)	92.0	Yes	Ramp Slope (%)	8.1
Yes	Ramp Width (in)	49.5	No	Ramp XSlope (%)	2.6
N/A	Flare Type LT	Sloped	N/A	Flare Type RT	N/A
N/A	Flare Slope LT (%)	2.5	N/A	Flare Slope RT (%)	7.1
N/A	Flare Traversable LT?	No	N/A	Flare Traversable RT?	No
Yes	Landing Length (in)	96.0	Yes	DWS Provided?	Yes
No	Landing Width (in)	47.0	Yes	DWS Contrast?	Yes
No	Landing Slope (%)	2.6	Yes	DWS Length (in)	24.0
No	Landing X Slope (%)	2.2	Yes	DWS Full Width?	Yes
N/A	Landing Curb? (Y/N)	No	Yes	DWS Offset (in)	0.0
N/A	Shared Landing?	No			
Yes	Gutter Ponding?	No	Yes	Gutter Slope (%)	1.5
No	Gutter Lip Ht (in)	1.5	No	Gutter X Slope (%)	4.9
N/A	Painted X Walk1?	No	N/A	Painted X Walk2?	No
	X Walk 1 Direction	To NW		X Walk 2 Direction	To SW
N/A	X Walk 1 Width (in)	N/A	N/A	X Walk 2 Width (in)	N/A
	X Walk 1 Slope (%)	1.8		X Walk 2 Slope (%)	3.5
	X Walk 1 X Slope (%)	4.0		X Walk 2 X Slope (%)	3.6

N/A	Ramp inside XWalk1?	N/A	N/A	Ramp inside XWalk2?	N/A
	Road Slope (%)	4.5	N/A	Clear Space?	Yes
	Road X Slope (%)	0.7	N/A	Clear Space to XWalk (in)	N/A
Yes	Any Obstructions?	No	Yes	Storm Grate/Utility Hazard?	No
	Obstruction Type			Storm Grate/Utility Type	
		N/A			N/A
			Yes	Surface Condition? (G/P)	Good

Possible Solutions:

**Remove & Replace Curb Ramp With Two New Directional Ramps or Equivalent. Remove & Replace Gutter.**
