Access Compliance Report

Public Rights-of-Way

(Curb Ramps)

Intersection ID: 12329	Main Street: E_15TH_ST	Cross Street: PEGRAM_ST	Location:	N
ADA ID: 560FD801AB4A	Ramp Type: Perp	Initial Pass/Fail: Fail	Overall Compliance: No	Severity Score: 8.75
Codes/Mitigation Info/Possible Solution		Field Measurements/Component Compliance

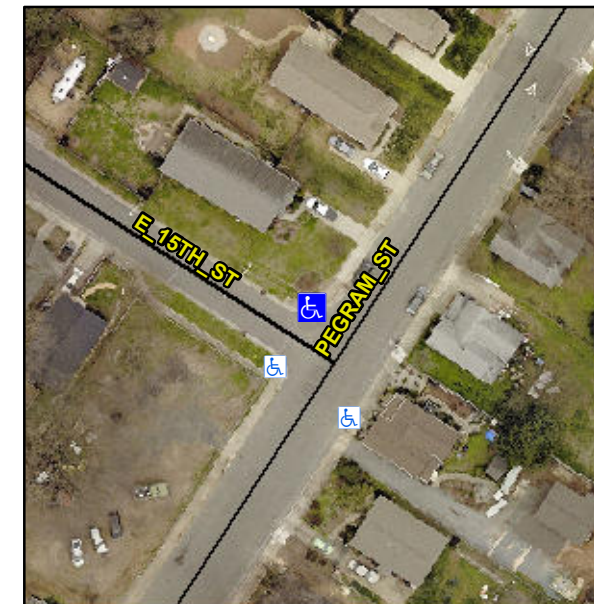
Not Found, R304.5.1

Compliance	Description	Data	Compliance	Description	Data
N/A	Ramp Length (in)	69.5	Yes	Ramp Slope (%)	7.5
No	Ramp Width (in)	39.0	Yes	Ramp XSlope (%)	1.9
N/A	Flare Type LT	N/A	N/A	Flare Type RT	N/A
N/A	Flare Slope LT (%)	N/A	N/A	Flare Slope RT (%)	N/A
N/A	Flare Traversable LT?	N/A	N/A	Flare Traversable RT?	N/A
N/A	Landing Length (in)	N/A	N/A	DWS Provided?	N/A
N/A	Landing Width (in)	N/A	N/A	DWS Contrast?	N/A
N/A	Landing Slope (%)	N/A	N/A	DWS Length (in)	N/A
N/A	Landing X Slope (%)	N/A	N/A	DWS Full Width?	N/A
N/A	Landing Curb? (Y/N)	N/A	N/A	DWS Offset (in)	N/A
N/A	Shared Landing?	N/A			
N/A	Gutter Ponding?	N/A	N/A	Gutter Slope (%)	N/A
N/A	Gutter Lip Ht (in)	N/A	N/A	Gutter X Slope (%)	N/A
N/A	Painted X Walk1?	No	N/A	Painted X Walk2?	N/A
	X Walk 1 Direction	To SW		X Walk 2 Direction	N/A
N/A	X Walk 1 Width (in)	N/A	N/A	X Walk 2 Width (in)	N/A
	X Walk 1 Slope (%)	2.4		X Walk 2 Slope (%)	N/A
	X Walk 1 X Slope (%)	1.2		X Walk 2 X Slope (%)	N/A

N/A	Ramp inside XWalk1?	N/A	N/A	Ramp inside XWalk2?	N/A
	Road Slope (%)	N/A	N/A	Clear Space?	N/A
	Road X Slope (%)	N/A	N/A	Clear Space to XWalk (in)	N/A
N/A	Any Obstructions?	N/A	N/A	Storm Grate/Utility Hazard?	N/A
	Obstruction Type			Storm Grate/Utility Type	
		N/A			N/A
			Yes	Surface Condition? (G/P)	Good

Possible Solutions:

Remove & Replace Entire Ramp.
