Access Compliance Report

Public Rights-of-Way

(Curb Ramps)

Intersection ID: 50602	Main Street: RHODORA_RD	Cross Street: CEDARFIELD_RD	Location: NW
ADA ID: 562D53512C97	Ramp Type: Perp	Initial Pass/Fail: Fail	Overall Compliance: No
		Severity Score: 22.5

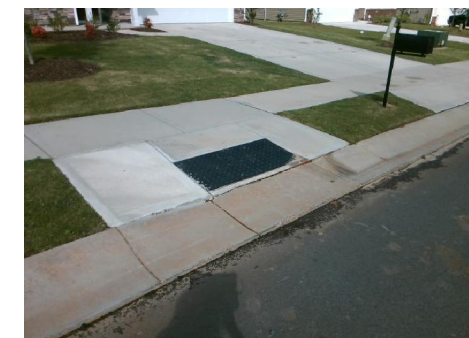
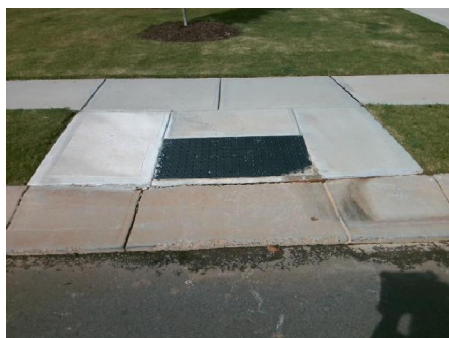
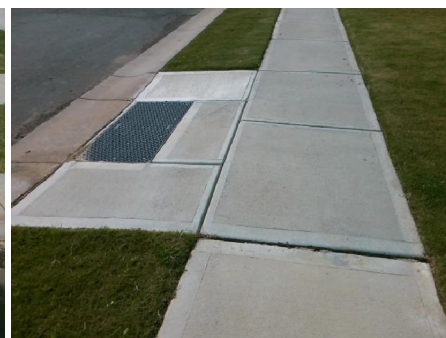
Not Found, R304.5.1, R304.2.2

Compliance	Description	Data	Compliance	Description	Data
N/A	Ramp Length (in)	48.5	No	Ramp Slope (%)	10.4
No	Ramp Width (in)	47.0	Yes	Ramp XSlope (%)	2.5
N/A	Flare Type LT	N/A	N/A	Flare Type RT	N/A
N/A	Flare Slope LT (%)	N/A	N/A	Flare Slope RT (%)	N/A
N/A	Flare Traversable LT?	N/A	N/A	Flare Traversable RT?	N/A
N/A	Landing Length (in)	N/A	N/A	DWS Provided?	N/A
N/A	Landing Width (in)	N/A	N/A	DWS Contrast?	N/A
N/A	Landing Slope (%)	N/A	N/A	DWS Length (in)	N/A
N/A	Landing X Slope (%)	N/A	N/A	DWS Full Width?	N/A
N/A	Landing Curb? (Y/N)	N/A	N/A	DWS Offset (in)	N/A
N/A	Shared Landing?	N/A			
N/A	Gutter Ponding?	N/A	N/A	Gutter Slope (%)	N/A
N/A	Gutter Lip Ht (in)	N/A	N/A	Gutter X Slope (%)	N/A
N/A	Painted X Walk1?	No	N/A	Painted X Walk2?	N/A
	X Walk 1 Direction	To E		X Walk 2 Direction	N/A
N/A	X Walk 1 Width (in)	N/A	N/A	X Walk 2 Width (in)	N/A
	X Walk 1 Slope (%)	4.5		X Walk 2 Slope (%)	N/A
	X Walk 1 X Slope (%)	2.9		X Walk 2 X Slope (%)	N/A

Remove & Replace Entire Ramp.
