# Access Compliance Report

## Public Rights-of-Way

### (Curb Ramps)

Intersection ID: N/A	Main Street: STEELE_CREEK_RD	Cross Street: BEREWICK_COMMONS_PY	Location: NW
ADA ID: 562EAC2EB8BC	Ramp Type: PerpDiag	Initial Pass/Fail: Fail	Overall Compliance: No
		Severity Score: 12.5

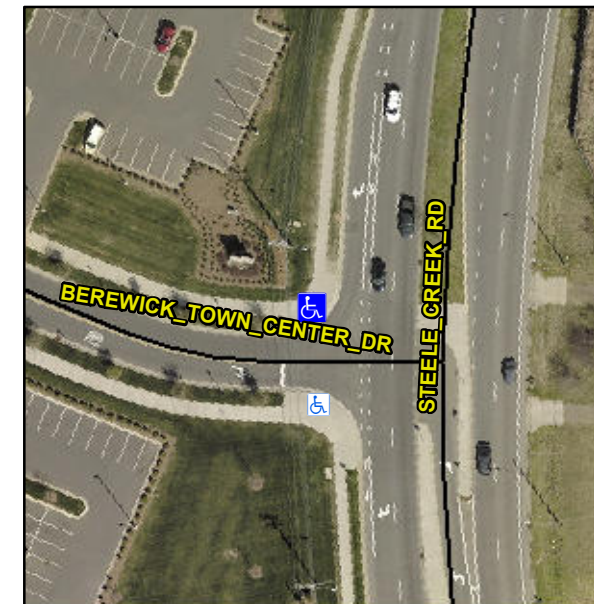
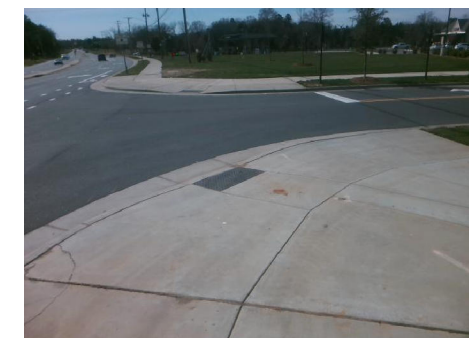
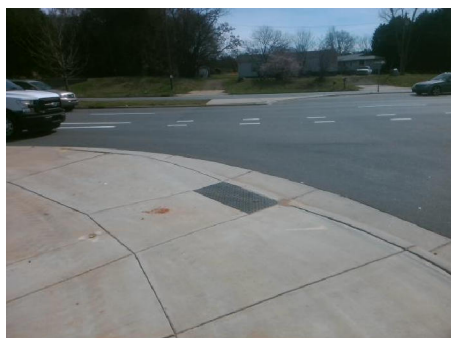
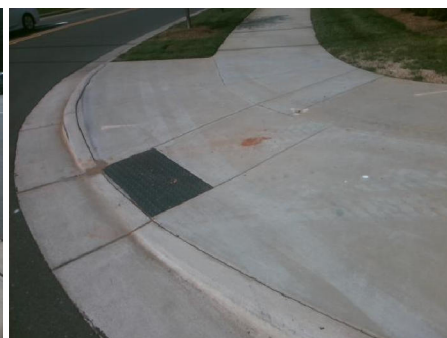
Compliance	Description	Data	Compliance	Description	Data
N/A	Ramp Length (in)	86.0	Yes	Ramp Slope (%)	6.0
Yes	Ramp Width (in)	48.0	No	Ramp XSlope (%)	6.6
N/A	Flare Type LT	N/A	N/A	Flare Type RT	N/A
N/A	Flare Slope LT (%)	N/A	N/A	Flare Slope RT (%)	N/A
N/A	Flare Traversable LT?	N/A	N/A	Flare Traversable RT?	N/A
N/A	Landing Length (in)	N/A	N/A	DWS Provided?	N/A
N/A	Landing Width (in)	N/A	N/A	DWS Contrast?	N/A
N/A	Landing Slope (%)	N/A	N/A	DWS Length (in)	N/A
N/A	Landing X Slope (%)	N/A	N/A	DWS Full Width?	N/A
N/A	Landing Curb? (Y/N)	N/A	N/A	DWS Offset (in)	N/A
N/A	Shared Landing?	N/A			
N/A	Gutter Ponding?	N/A	N/A	Gutter Slope (%)	N/A
N/A	Gutter Lip Ht (in)	N/A	N/A	Gutter X Slope (%)	N/A
N/A	Painted X Walk1?	No	N/A	Painted X Walk2?	No
	X Walk 1 Direction	To S		X Walk 2 Direction	To SE
N/A	X Walk 1 Width (in)	N/A	N/A	X Walk 2 Width (in)	N/A
	X Walk 1 Slope (%)	3.5		X Walk 2 Slope (%)	2.5
	X Walk 1 X Slope (%)	2.8		X Walk 2 X Slope (%)	3.6

N/A	Ramp inside XWalk1?	N/A	N/A	Ramp inside XWalk2?	N/A
	Road Slope (%)	4.2	N/A	Clear Space?	N/A
	Road X Slope (%)	0.9	N/A	Clear Space to XWalk (in)	N/A
N/A	Any Obstructions?	N/A	N/A	Storm Grate/Utility Hazard?	N/A
	Obstruction Type			Storm Grate/Utility Type	
		N/A			N/A
			Yes	Surface Condition? (G/P)	Good

**Remove & Replace Curb Ramp With Two New Directional Ramps or Equivalent.**

**Not Found, R304.5.3**
