Access Compliance Report

Public Rights-of-Way

(Curb Ramps)

Intersection ID: 31378	Main Street: CARRINGTON_HILL_DR	Cross Street: AUBREYWOOD_DR	Location: W
ADA ID: 5639DB1B631F	Ramp Type: PerpDiag	Initial Pass/Fail: Fail	Overall Compliance: No
Codes/Mitigation Info/Possible Solution		Field Measurements/Component Compliance	
Severity Score: 46.25

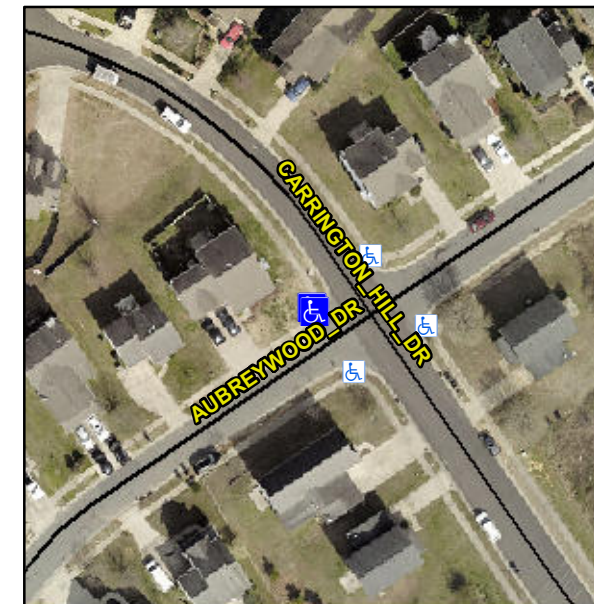
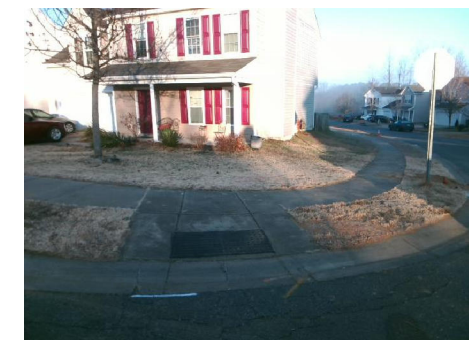
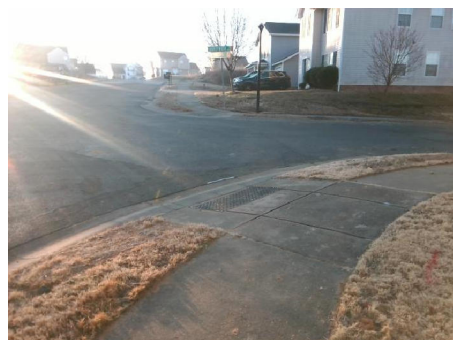
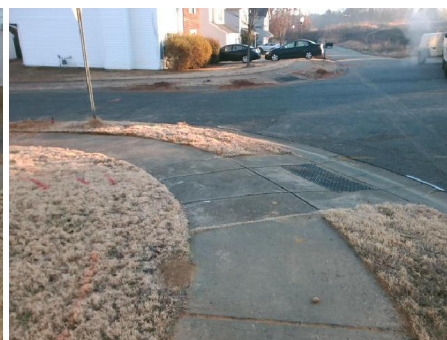
Not Found, R304.5.1, R304.2.2, R304.5.3

Compliance	Description	Data	Compliance	Description	Data
N/A	Ramp Length (in)	48.0	No	Ramp Slope (%)	12.2
No	Ramp Width (in)	40.5	No	Ramp XSlope (%)	6.4
N/A	Flare Type LT	N/A	N/A	Flare Type RT	N/A
N/A	Flare Slope LT (%)	N/A	N/A	Flare Slope RT (%)	N/A
N/A	Flare Traversable LT?	N/A	N/A	Flare Traversable RT?	N/A
N/A	Landing Length (in)	N/A	N/A	DWS Provided?	N/A
N/A	Landing Width (in)	N/A	N/A	DWS Contrast?	N/A
N/A	Landing Slope (%)	N/A	N/A	DWS Length (in)	N/A
N/A	Landing X Slope (%)	N/A	N/A	DWS Full Width?	N/A
N/A	Landing Curb? (Y/N)	N/A	N/A	DWS Offset (in)	N/A
N/A	Shared Landing?	N/A			
N/A	Gutter Ponding?	N/A	N/A	Gutter Slope (%)	N/A
N/A	Gutter Lip Ht (in)	N/A	N/A	Gutter X Slope (%)	N/A
N/A	Painted X Walk1?	No	N/A	Painted X Walk2?	No
	X Walk 1 Direction	To SE		X Walk 2 Direction	To NE
N/A	X Walk 1 Width (in)	N/A	N/A	X Walk 2 Width (in)	N/A
	X Walk 1 Slope (%)	11.9		X Walk 2 Slope (%)	4.1
	X Walk 1 X Slope (%)	0.8		X Walk 2 X Slope (%)	9.6

N/A	Ramp inside XWalk1?	N/A	N/A	Ramp inside XWalk2?	N/A
	Road Slope (%)	4.4	N/A	Clear Space?	N/A
	Road X Slope (%)	9.9	N/A	Clear Space to XWalk (in)	N/A
N/A	Any Obstructions?	N/A	N/A	Storm Grate/Utility Hazard?	N/A
	Obstruction Type			Storm Grate/Utility Type	
		N/A			N/A
			Yes	Surface Condition? (G/P)	Good

Remove & Replace Curb Ramp With Two New Directional Ramps or Equivalent.
