Access Compliance Report

Public Rights-of-Way

(Curb Ramps)

Intersection ID: 8968	Main Street: CELIA_AV	Cross Street: ONYX_ST	Location: NE
ADA ID: 563E24496A8A	Ramp Type: BlendTrans2	Initial Pass/Fail: Fail	Overall Compliance: No
		Severity Score: 8.75

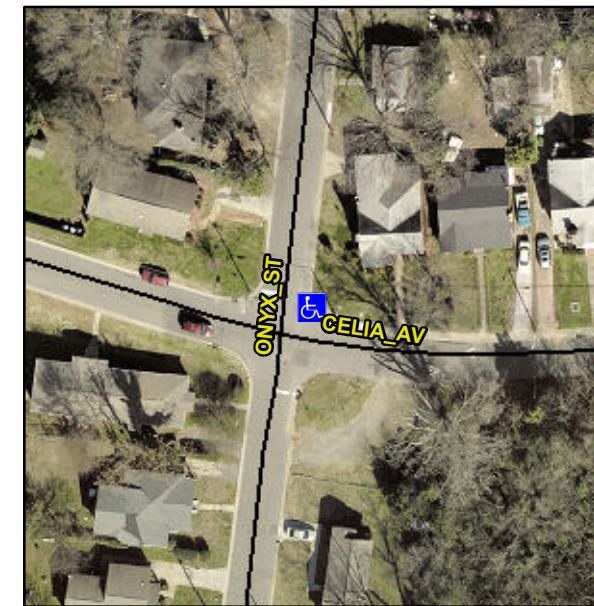
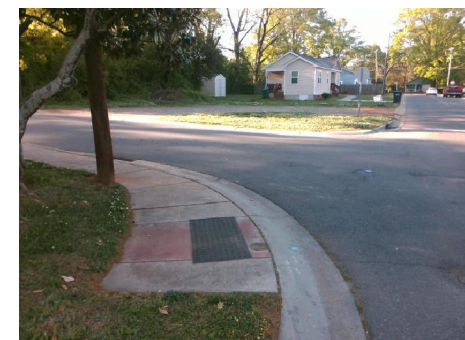
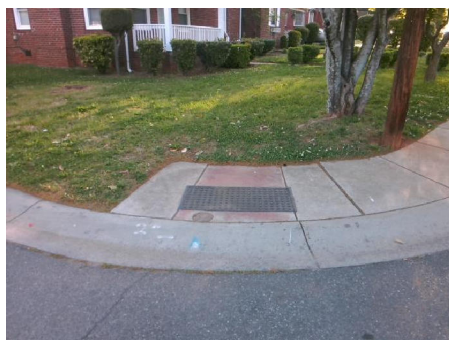
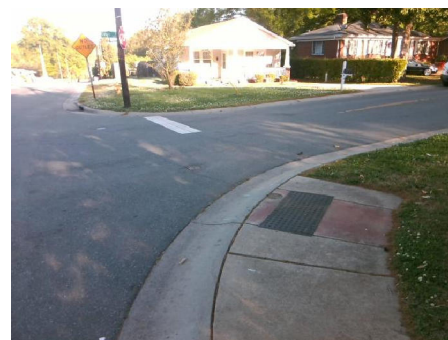
Not Found, R304.5.1

Compliance	Description	Data	Compliance	Description	Data
N/A	Ramp Length (in)	62.0	Yes	BlendTrans Slope (%)	1.7
No	Ramp Width (in)	39.0	Yes	BlendTrans XSlope (%)	0.8
N/A	Flare Type LT	N/A	N/A	Flare Type RT	N/A
N/A	Flare Slope LT (%)	N/A	N/A	Flare Slope RT (%)	N/A
N/A	Flare Traversable LT?	N/A	N/A	Flare Traversable RT?	N/A
N/A	Landing Length (in)	N/A	N/A	DWS Provided?	N/A
N/A	Landing Width (in)	N/A	N/A	DWS Contrast?	N/A
N/A	Landing Slope (%)	N/A	N/A	DWS Length (in)	N/A
N/A	Landing X Slope (%)	N/A	N/A	DWS Full Width?	N/A
N/A	Landing Curb? (Y/N)	N/A	N/A	DWS Offset (in)	N/A
N/A	Shared Landing?	N/A			
N/A	Gutter Ponding?	N/A	N/A	Gutter Slope (%)	N/A
N/A	Gutter Lip Ht (in)	N/A	N/A	Gutter X Slope (%)	N/A
N/A	Painted X Walk1?	No	N/A	Painted X Walk2?	No
	X Walk 1 Direction	To W		X Walk 2 Direction	To S
	X Walk 1 Width (in)	N/A		X Walk 2 Width (in)	N/A
	X Walk 1 Slope (%)	N/A		X Walk 2 Slope (%)	N/A
	X Walk 1 X Slope (%)	N/A		X Walk 2 X Slope (%)	N/A

N/A	Ramp inside XWalk1?	N/A	N/A	Ramp inside XWalk2?	N/A
	Road Slope (%)	1.5		Clear Space?	N/A
	Road X Slope (%)	1.6	N/A	Clear Space to XWalk (in)	N/A
N/A	Any Obstructions?	N/A	N/A	Storm Grate/Utility Hazard?	N/A
	Obstruction Type			Storm Grate/Utility Type	
		N/A			N/A
			Yes	Surface Condition? (G/P)	Good
			No	Curb Slope (%)	30.8

Remove & Replace Curb Ramp With Two New Directional Ramps or Equivalent.
