Access Compliance Report

Public Rights-of-Way

(Curb Ramps)

| Intersection ID: 47810 | Main Street: NEVIN_GLEN_DR | Cross Street: GRAYPARK_DR | Location: NW |

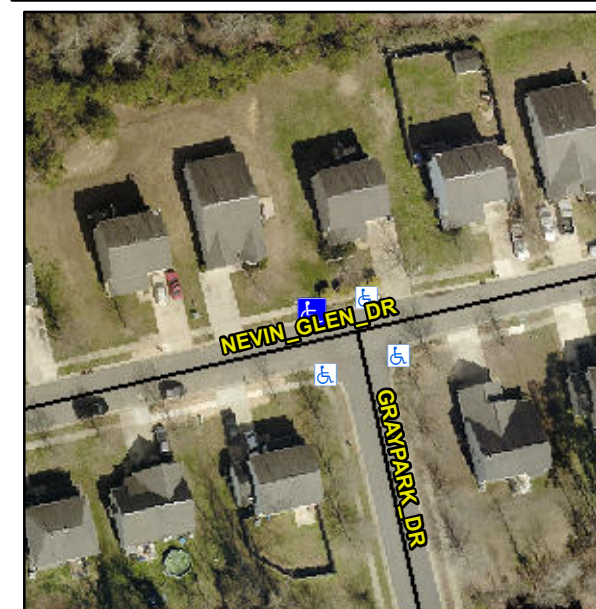
| Severity Score: 10 | | | |

PROW/ADA:

Not Found, R304.5.1

| Compliance | Description | Data | Compliance | Description | Data |
|---|---|---|---|---|---|
| No | Ramp Width (in) | 47.0 | Yes | Ramp XSlope (%) | 3.4 |

Possible Solutions:

Remove & Replace Entire Ramp.

Total Cost: \$ 1850.00
