Intersection ID: 13296	Main Street: CENTRAL_AV	Cross Street: MORNINGSIDE_DR	Location:	NE
ADA ID: 564FA771CEC6	Ramp Type: Perp	Initial Pass/Fail: Fail	Overall Compliance: No	Severity Score: 10

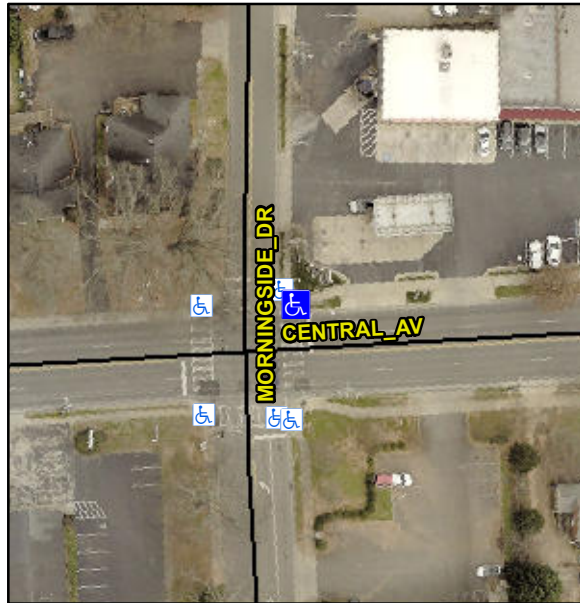
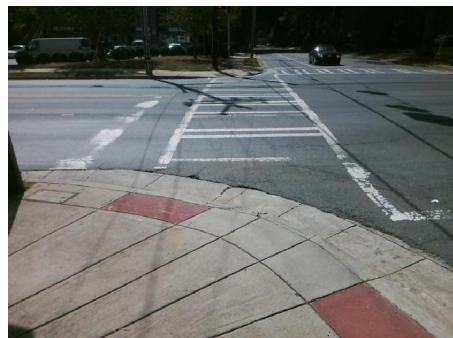
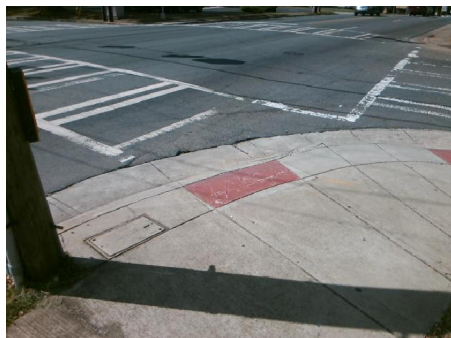
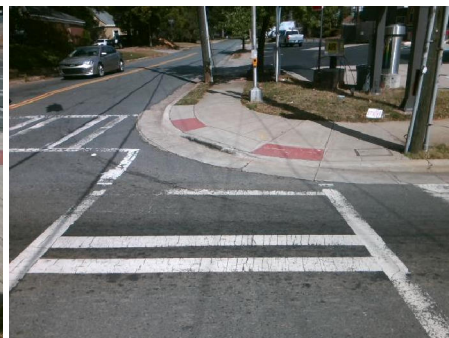
Possible Solutions:			Compliance	Description	Data	Compliance	Description	Data
Remove & Replace Entire Ramp.			N/A	Ramp Length (in)	93.0	Yes	Ramp Slope (%)	8.2
			No	Ramp Width (in)	40.0	Yes	Ramp XSlope (%)	2.7
			N/A	Flare Type LT	N/A	N/A	Flare Type RT	N/A
			N/A	Flare Slope LT (%)	N/A	N/A	Flare Slope RT (%)	N/A
			N/A	Flare Traversable LT?	N/A	N/A	Flare Traversable RT?	N/A
			N/A	Landing Length (in)	N/A	N/A	DWS Provided?	N/A
			N/A	Landing Width (in)	N/A	N/A	DWS Contrast?	N/A
			N/A	Landing Slope (%)	N/A	N/A	DWS Length (in)	N/A
			N/A	Landing X Slope (%)	N/A	N/A	DWS Full Width?	N/A
			N/A	Landing Curb? (Y/N)	N/A	N/A	DWS Offset (in)	N/A
			N/A	Shared Landing?	N/A			
			N/A	Gutter Ponding?	N/A	N/A	Gutter Slope (%)	N/A
Surveyor Notes: N/A			N/A	Gutter Lip Ht (in)	2.5	N/A	Gutter X Slope (%)	N/A
			N/A	Painted X Walk1?	Yes	N/A	Painted X Walk2?	N/A
				X Walk 1 Direction	To S		X Walk 2 Direction	N/A
			N/A	X Walk 1 Width (in)	110.5	N/A	X Walk 2 Width (in)	N/A

X Walk 1 Slope (%)	4.5		X Walk 2 Slope (%)	N/A
				X Walk 1 X Slope (%)	3.6		X Walk 2 X Slope (%)	N/A
			N/A	Ramp inside XWalk1?	Yes	N/A	Ramp inside XWalk2?	N/A
				Road Slope (%)	N/A	N/A	Clear Space?	N/A
				Road X Slope (%)	N/A	N/A	Clear Space to XWalk (in)	N/A
			N/A	Any Obstructions?	N/A	N/A	Storm Grate/Utility Hazard?	N/A
				Obstruction Type			Storm Grate/Utility Type	
					N/A			N/A
Total Cost: \$ 1850.00						Yes	Surface Condition? (G/P)	Good

Possible Solutions:

Remove & Replace Entire Ramp.

Not Found, R304.5.1
