Access Compliance Report

Public Rights-of-Way

(Curb Ramps)

Intersection ID: 28456	Main Street: SUMMER_CREEK_LN	Cross Street: BENFIELD_RD	Location: SW
ADA ID: 565A689D544C	Ramp Type: Directional1	Initial Pass/Fail: Fail	Overall Compliance: No
		Severity Score: 1.25

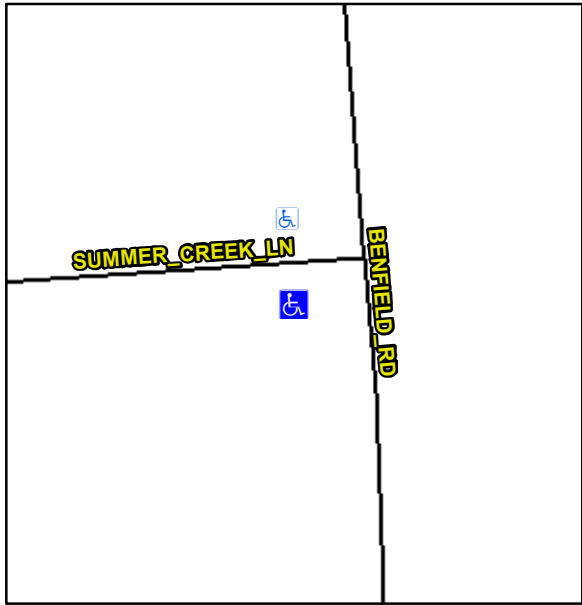
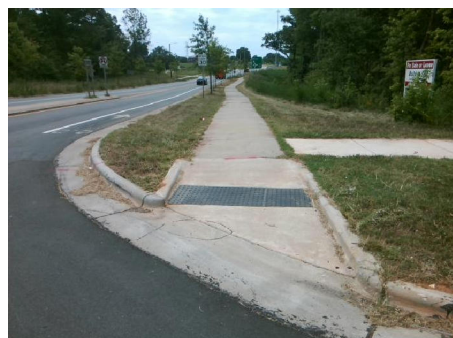
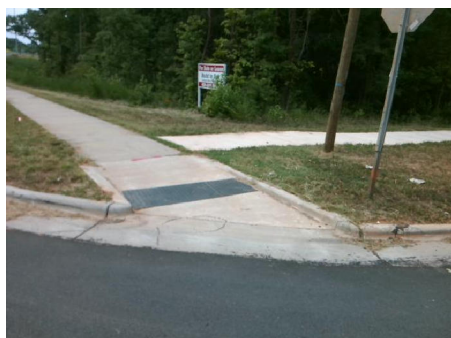
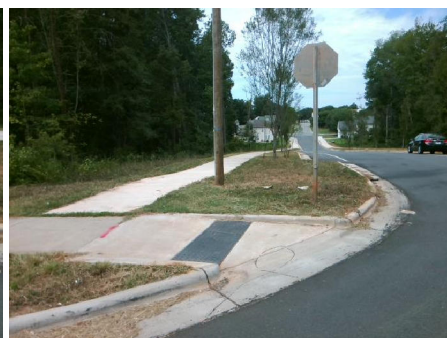
Possible Solutions:		Compliance	Description	Data	Compliance	Description	Data
	Remove & Replace Entire Ramp.		N/A	Ramp Length (in)	74.0	N/A	Grade Break?	N/A
			Yes	Ramp Width (in)	72.0	N/A	Grade Break Slope (%)	0.0
			Yes	Ramp Slope (%)	6.6	N/A	Grade Break XSlope (%)	0.0
			No	Ramp XSlope (%)	3.0			
			N/A	Flare Type LT	N/A	N/A	Flare Type RT	N/A
			N/A	Flare Slope LT (%)	N/A	N/A	Flare Slope RT (%)	0.0
			N/A	Flare Traversable LT?	N/A	N/A	Flare Traversable RT?	N/A
			N/A	Landing Length (in)	0.0	N/A	DWS Provided?	N/A
			N/A	Landing Width (in)	0.0	N/A	DWS Contrast?	N/A
			N/A	Landing Slope (%)	0.0	N/A	DWS Length (in)	N/A
			N/A	Landing X Slope (%)	0.0	N/A	DWS Full Width?	N/A
			N/A	Landing Curb? (Y/N)	N/A	N/A	DWS Offset LT (in)	N/A
			N/A	Shared Landing?	N/A	N/A	DWS Offset RT (in)	N/A
			N/A	Gutter Ponding?	0.0	N/A	Gutter Slope (%)	N/A

N/A	Gutter Lip Ht (in)	0.0	N/A	Gutter X Slope (%)	N/A
			N/A	Painted X Walk1?	No		Road Slope (%)	5.0
				X Walk 1 Direction	To N		Road X Slope (%)	2.2
				X Walk 1 Width (in)	N/A		Clear Space?	N/A
				X Walk 1 Slope (%)	5.0	N/A	Clear Space to XWalk (in)	N/A
				X Walk 1 X Slope (%)	2.2	N/A	Storm Grate/Utility Hazard?	N/A
			N/A	Ramp inside XWalk1?	N/A		Storm Grate/Utility Type	
			N/A	Any Obstructions?	N/A			N/A
				Obstruction Type		Yes	Surface Condition? (G/P)	Good
						N/A	Curb Slope (%)	13.2
Total Cost:		\$	1600.00					
Street 1 Name		SUMMER CREEK LN						
Stop Condition-Street 1		StopSign						
Street 2 Name		N/A						
Stop Condition-Street 2		N/A						
PROW/ADA:		R304.5.3						
Surveyor Notes:		N/A
