## **Access Compliance Report Public Rights-of-Way** (Curb Ramps)

Intersection ID: 46725 Main Street: FAWN VIEW DR **Cross Street: HAMILTON FOREST DR** Location: ADA ID: 565CF805FB5C Ramp Type: PerpDiag Initial Pass/Fail: Fail **Overall Compliance: No** Severity Score: 21.25

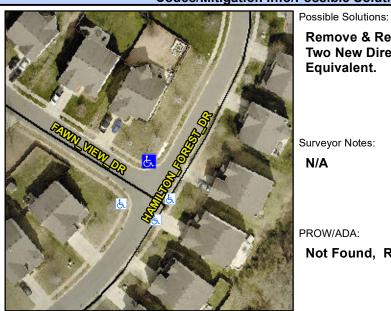
Not Found, R304.5.1, R304.2.2

Field Measurements/Component Compilance						
Compliance Description		Data	Compliance Description		Data	
N/A	Ramp Length (in)	47.0	No	Ramp Slope (%)	9.5	
No	Ramp Width (in)	38.5	Yes	Ramp XSlope (%)	1.8	
N/A	Flare Type LT	N/A	N/A	Flare Type RT	N/A	
N/A	Flare Slope LT (%)	N/A	N/A	Flare Slope RT (%)	N/A	
N/A	Flare Traversable LT?	N/A	N/A	Flare Traversable RT?	N/A	
N/A	Landing Length (in)	N/A	N/A	DWS Provided?	N/A	
N/A	Landing Width (in)	N/A	N/A	DWS Contrast?	N/A	
N/A	Landing Slope (%)	N/A	N/A	DWS Length (in)	N/A	
N/A	Landing X Slope (%)	N/A	N/A	DWS Full Width?	N/A	
N/A	Landing Curb? (Y/N)	N/A	N/A	DWS Offset (in)	N/A	
N/A	Shared Landing?	N/A				
N/A	Gutter Ponding?	N/A	N/A	Gutter Slope (%)	N/A	
N/A	Gutter Lip Ht (in)	N/A	N/A	Gutter X Slope (%)	N/A	
N/A	Painted X Walk1?	No	N/A	Painted X Walk2?	No	
	X Walk 1 Direction	To SW		X Walk 2 Direction	To SE	
N/A	X Walk 1 Width (in)	N/A	N/A	X Walk 2 Width (in)	N/A	
	X Walk 1 Slope (%)	3.6		X Walk 2 Slope (%)	1.4

X Walk 1 X Slope (%)	0.1		X Walk 2 X Slope (%)	2.3	
N/A	Ramp inside XWalk1?	N/A	N/A	Ramp inside XWalk2?	N/A	
	Road Slope (%)	1.0	N/A	Clear Space?	N/A	
	Road X Slope (%)	5.9	N/A	Clear Space to XWalk (in)	N/A	
N/A	Any Obstructions?	N/A	N/A	Storm Grate/Utility Hazard?	N/A	
	Obstruction Type			Storm Grate/Utility Type		
		N/A			N/A	
			Yes	Surface Condition? (G/P)	Good

Remove & Replace Curb Ramp With Two New Directional Ramps or Equivalent.
