# Access Compliance Report Public Rights-of-Way (Curb Ramps)

Intersection ID: 25627      Main Street: KATHRYN BLAIR LN      Cross Street: STALLWORTH DR      Location: NE

ADA ID: 565D6C13A7BA      Ramp Type: PerpDiag      Initial Pass/Fail: Fail      Overall Compliance: No      Severity Score: 8.75

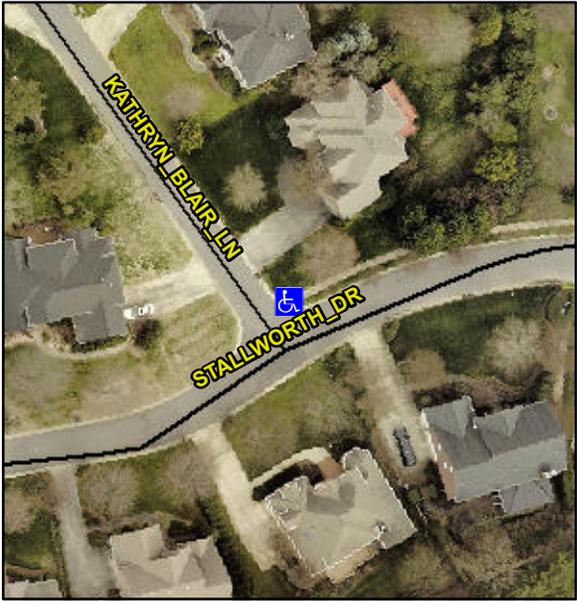
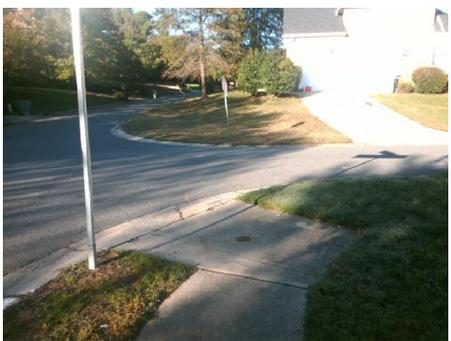
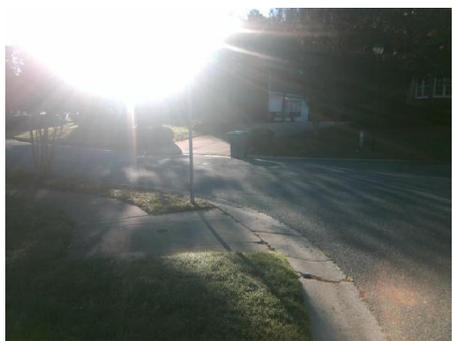
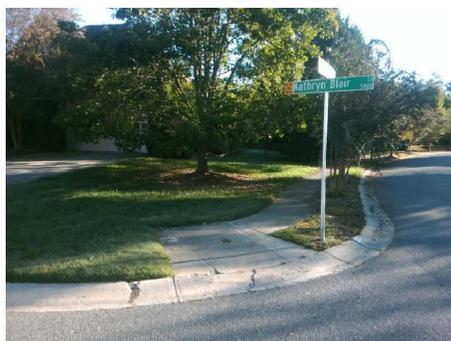
Compliance	Description	Data	Compliance	Description	Data
N/A	Ramp Length (in)	66.0	Yes	Ramp Slope (%)	5.3
No	Ramp Width (in)	47.0	Yes	Ramp XSlope (%)	1.3
N/A	Flare Type LT	N/A	N/A	Flare Type RT	N/A
N/A	Flare Slope LT (%)	N/A	N/A	Flare Slope RT (%)	N/A
N/A	Flare Traversable LT?	N/A	N/A	Flare Traversable RT?	N/A
N/A	Landing Length (in)	N/A	N/A	DWS Provided?	N/A
N/A	Landing Width (in)	N/A	N/A	DWS Contrast?	N/A
N/A	Landing Slope (%)	N/A	N/A	DWS Length (in)	N/A
N/A	Landing X Slope (%)	N/A	N/A	DWS Full Width?	N/A
N/A	Landing Curb? (Y/N)	N/A	N/A	DWS Offset (in)	N/A
N/A	Shared Landing?	N/A			
N/A	Gutter Ponding?	N/A	N/A	Gutter Slope (%)	N/A
N/A	Gutter Lip Ht (in)	N/A	N/A	Gutter X Slope (%)	N/A
N/A	Painted X Walk1?	No	N/A	Painted X Walk2?	No
	X Walk 1 Direction	To W		X Walk 2 Direction	To S
N/A	X Walk 1 Width (in)	N/A	N/A	X Walk 2 Width (in)	N/A
	X Walk 1 Slope (%)	7.8		X Walk 2 Slope (%)	3.5
	X Walk 1 X Slope (%)	2.3		X Walk 2 X Slope (%)	6.0

N/A	Ramp inside XWalk1?	N/A	N/A	Ramp inside XWalk2?	N/A
	Road Slope (%)	1.0	N/A	Clear Space?	N/A
	Road X Slope (%)	7.2	N/A	Clear Space to XWalk (in)	N/A
N/A	Any Obstructions?	N/A	N/A	Storm Grate/Utility Hazard?	N/A
	Obstruction Type			Storm Grate/Utility Type	
		N/A			N/A
			Yes	Surface Condition? (G/P)	Good

Possible Solutions:  
**Remove & Replace Curb Ramp With Two New Directional Ramps or Equivalent.**

PROW/ADA:  
**R304.5.1**

Total Cost:                                    \$    **3200.00**
