Surface Condition? (G/P)

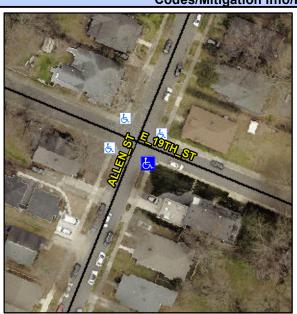
Intersection ID: 11810 Main Street: ALLEN_ST Cross Street: E_19TH_ST Location: S

PROW/ADA:

Total Cost: \$ 3200.00

Possible Solutions:
