| Intersection ID: 3448 | Main Street: W W T HARRIS BV TO I-77 RA SB | Ramp Street: I-77 TO W W T HARRIS BV RA SB | Location: | SW |
| ADA ID: 5672D84B1335 | Ramp Type: Perp | Initial Pass/Fail: Pass | Overall Compliance: No | Severity Score: 10.25 |

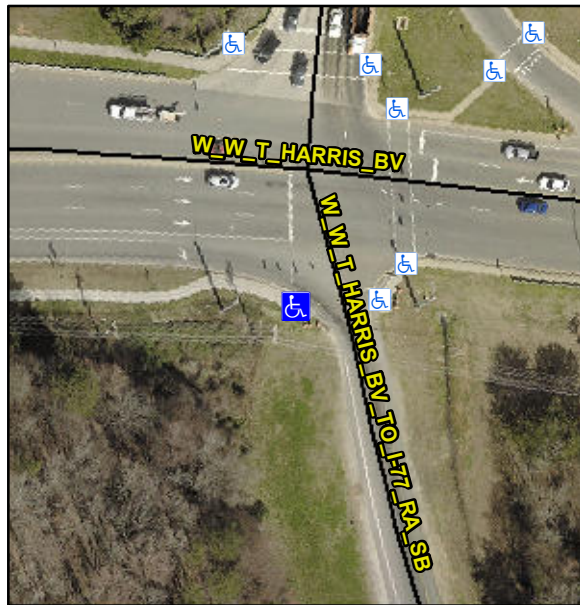
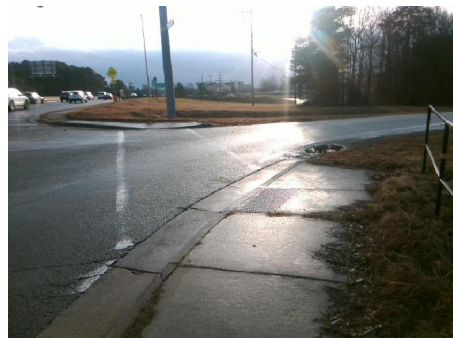
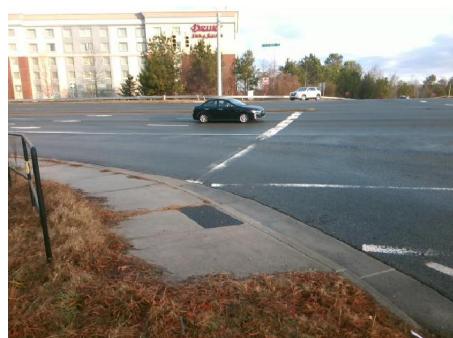
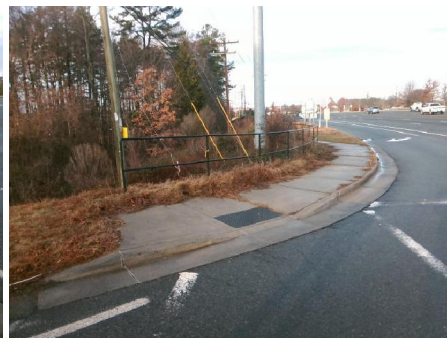
**Not Found, R304.5.3, R304.2.1,  
R304.2.2-Perp, R304.3.2-Para,  
R305.2**

| Compliance | Description | Data | Compliance | Description | Data |
|---|---|---|---|---|---|
| Yes | Ramp Width (in) | 48.0 | No | Ramp XSlope (%) | 4.1 |
| No | Landing Length (in) | N/A | Yes | DWS Provided? | Yes |
| No | Landing Width (in) | N/A | Yes | DWS Contrast? | Yes |
| No | Landing Slope (%) | N/A | Yes | DWS Length (in) | 24.0 |
| No | Landing X Slope (%) | N/A | Yes | DWS Full Width? | Yes |
| N/A | Landing Curb? (Y/N) | No | No | DWS Offset (in) | 2.5 |

### Remove & Replace Entire Ramp.

Total Cost: \$ 1850.00
