Access Compliance Report

Public Rights-of-Way

(Curb Ramps)

| Intersection ID: 44943 | Main Street: COLTART_CT | Cross Street: LARIMER_LN | Location: W |

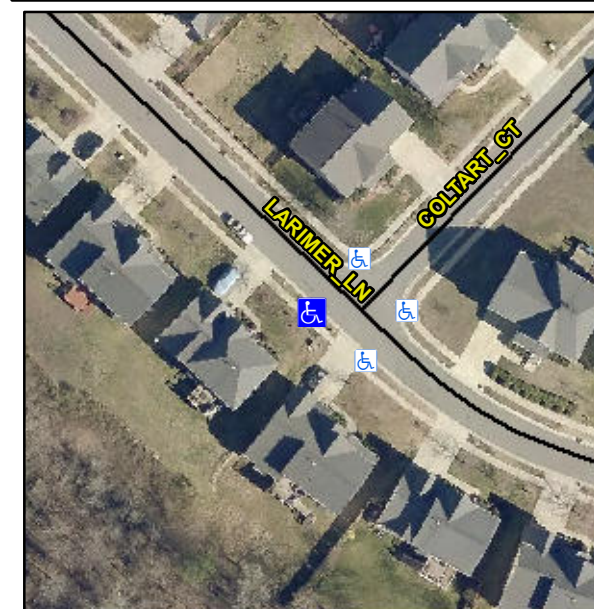
| ADA ID: 56747779E05B | Ramp Type: Perp | Initial Pass/Fail: Fail | Overall Compliance: No |
| Severity Score: 1.25 | | | |

Not Found, R304.5.3

| Compliance | Description | Data | Compliance | Description | Data |
|---|---|---|---|---|---|
| Yes | Ramp Width (in) | 48.0 | No | Ramp XSlope (%) | 3.0 |

Remove & Replace Entire Ramp.

\$ 1850.00
