# Access Compliance Report

## Public Rights-of-Way

### (Curb Ramps)

| Intersection ID: 7410 | Main Street: SQUIRREL_HILL_RD | Cross Street: WHITE_PLAINS_RD | Location: NE |

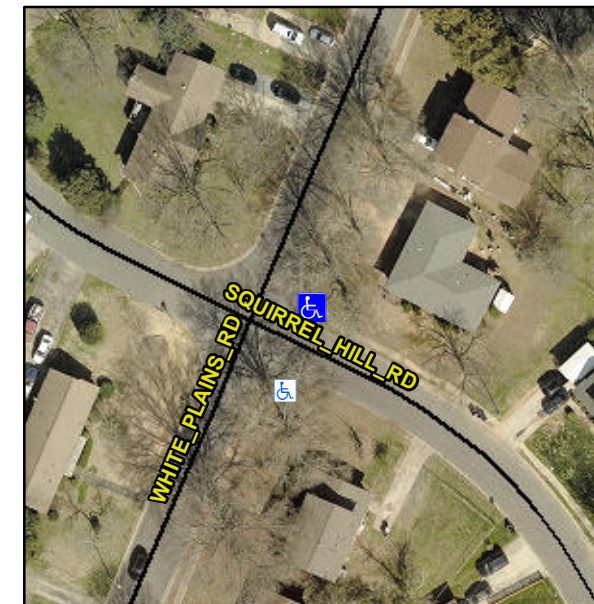
| ADA ID: 567DEF8B8FF3 | Ramp Type: BlendTrans1 | Initial Pass/Fail: Fail | Overall Compliance: No |

**Not Found, R304.5.1**

**Remove & Replace Curb Ramp With Two New Directional Ramps or Equivalent.**

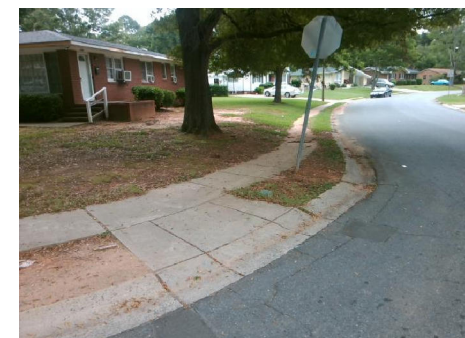
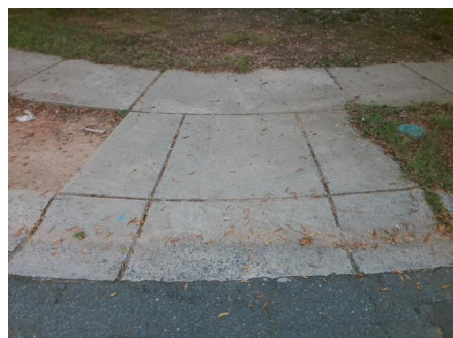
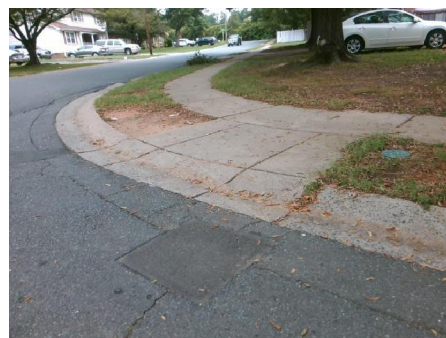
| Severity Score: 8.75 | | | |

| Compliance | Description | Data | Compliance | Description | Data |
|---|---|---|---|---|---|
| No | Ramp Width (in) | 41.0 | Yes | BlendTrans XSlope (%) | 0.1 |
| | | | No | Curb Slope (%) | 22.6 |

Total Cost: \$ 3200.00
