Access Compliance Report Public Rights-of-Way (Curb Ramps)

Intersection ID: 17718 Main Street: N_SHARON_AMITY_RD				ross Street: TANGLE_DR				Location:	NW
ADA ID: 56993A443FB3	ID: 56993A443FB3 Ramp Type: PerpDiag			nitial Pass/Fail: Fail Overall Compliance: No				o Severity Score:	22.5
Codes/Mitigation Info/Possible Solution				Field Measurements/Component Compliance					
		Possible Solutions:		Compliance Description		Data Compliance Description		Data	
X &		Remove & Replace Curb Ramp W	lith	N/A	Ramp Length (in)	60.0	No	Ramp Slope (%)	8.5
		Two New Directional Ramps or		No	Ramp Width (in)	47.5	No	Ramp XSlope (%)	3.2
En		Equivalent.		N/A	Flare Type LT	N/A	N/A	Flare Type RT	N/A
				N/A	Flare Slope LT (%)	N/A	N/A	Flare Slope RT (%)	N/A
				N/A	Flare Traversable LT?	N/A	N/A	Flare Traversable RT?	N/A
14				N/A	Landing Length (in)	N/A	N/A	DWS Provided?	N/A
A MARINE AND	G ST	Surveyor Notes:		N/A	Landing Width (in)	N/A	N/A	DWS Contrast?	N/A
A A A A A A A A A A A A A A A A A A A	Ser and a second	N/A		N/A	Landing Slope (%)	N/A	N/A	DWS Length (in)	N/A

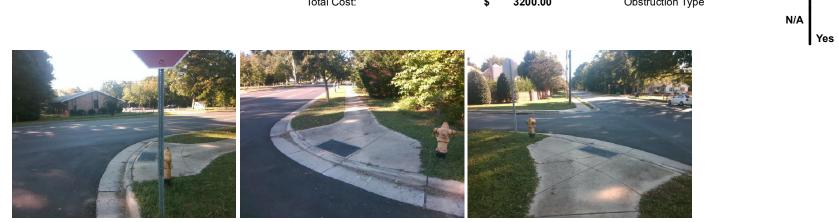
St	NA		N/A	Landing X Slope (%)	N/A	N/A	DWS Full Width?	N/A
EN IS	1 / Anima			N/A	Landing Curb? (Y/N)	N/A	N/A	DWS Offset (in)	N/A
S.	///			N/A	Shared Landing?	N/A		Dive ender (iii)	10/5

1. The Mar	PROW/ADA:		N/A	Gutter Ponding?	N/A	N/A	Gutter Slope (%)	N/A
				N/A	Gutter Lip Ht (in)	N/A	N/A	Gutter X Slope (%)	N/A
	A strange "	Not Found, R304.5.1, R304.2.2, R304.5.3		N/A	Painted X Walk1?	No	N/A	Painted X Walk2?	No
		K304.5.5		N/A	X Walk 1 Direction	To SE	N/A	X Walk 2 Direction	To NE
				N1/A			N 1/A		-
				N/A	X Walk 1 Width (in)	N/A	N/A	X Walk 2 Width (in)	N/A
Street 1 Name	N SHARON AMITY RD				X Walk 1 Slope (%)	0.1		X Walk 2 Slope (%)	3.7
Stop Condition-Street 2	None				X Walk 1 X Slope (%)	2.8		X Walk 2 X Slope (%)	1.0
Street 2 Name	TANGLE DR			N/A	Ramp inside XWalk1?	N/A	N/A	Ramp inside XWalk2?	N/A
Stop Condition-Street 1	StopSign				Road Slope (%)	1.9	N/A	Clear Space?	N/A
					Road X Slope (%)	2.8	N/A	Clear Space to XWalk (in)	N/A
				N/A	Any Obstructions?	N/A	N/A	Storm Grate/Utility Hazard?	N/A
		Total Cost: \$ 32	200.00		Obstruction Type			Storm Grate/Utility Type	
						N/A			N/A

es Surface Condition? (G/P)

Good
