Access Compliance Report

Public Rights-of-Way

(Curb Ramps)

Intersection ID: 14830	Main Street: ALBERTO_ST	Cross Street: CRESCENT_AV	Location: W
ADA ID: 569970530C1F	Ramp Type: Directional1	Initial Pass/Fail: Fail	Overall Compliance: No
Codes/Mitigation Info/Possible Solution		Field Measurements/Component Compliance	
Severity Score: 1.25

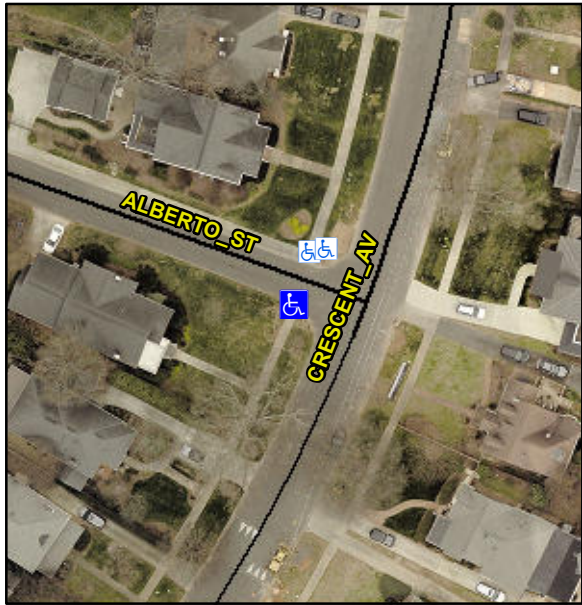
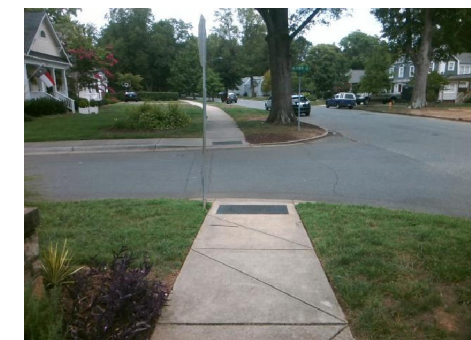
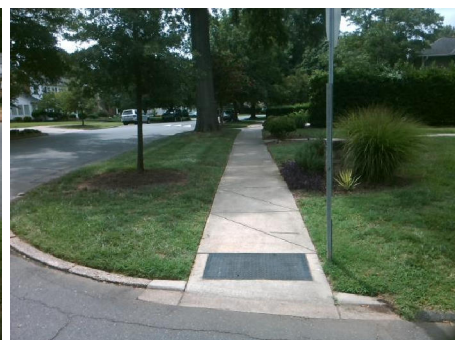
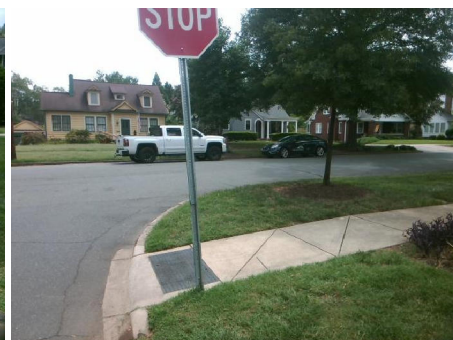
NO CURB LINE

Compliance	Description	Data	Compliance	Description	Data
N/A	Ramp Length (in)	100.0	N/A	Grade Break?	N/A
Yes	Ramp Width (in)	60.0	N/A	Grade Break Slope (%)	0.0
Yes	Ramp Slope (%)	7.1	N/A	Grade Break XSlope (%)	0.0
No	Ramp XSlope (%)	2.4			
N/A	Flare Type LT	N/A	N/A	Flare Type RT	N/A
N/A	Flare Slope LT (%)	N/A	N/A	Flare Slope RT (%)	0.0
N/A	Flare Traversable LT?	N/A	N/A	Flare Traversable RT?	N/A
N/A	Landing Length (in)	0.0	N/A	DWS Provided?	N/A
N/A	Landing Width (in)	0.0	N/A	DWS Contrast?	N/A
N/A	Landing Slope (%)	0.0	N/A	DWS Length (in)	N/A
N/A	Landing X Slope (%)	0.0	N/A	DWS Full Width?	N/A
N/A	Landing Curb? (Y/N)	N/A	N/A	DWS Offset LT (in)	N/A
N/A	Shared Landing?	N/A	N/A	DWS Offset RT (in)	N/A
N/A	Gutter Ponding?	0.0	N/A	Gutter Slope (%)	N/A
N/A	Gutter Lip Ht (in)	0.0	N/A	Gutter X Slope (%)	N/A
N/A	Painted X Walk1?	No		Road Slope (%)	1.2
	X Walk 1 Direction	To NE		Road X Slope (%)	1.0
	X Walk 1 Width (in)	N/A		Clear Space?	N/A

X Walk 1 Slope (%)	1.2	N/A	Clear Space to XWalk (in)	N/A
	X Walk 1 X Slope (%)	1.0	N/A	Storm Grate/Utility Hazard?	N/A
N/A	Ramp inside XWalk1?	N/A		Storm Grate/Utility Type	
N/A	Any Obstructions?	N/A			N/A
	Obstruction Type		Yes	Surface Condition? (G/P)	Good
		N/A	N/A	Curb Slope (%)	N/A

Possible Solutions:

Remove & Replace Entire Ramp.
