# Access Compliance Report

## Public Rights-of-Way

### (Curb Ramps)

Intersection ID: 52956	Main Street: OLD_POST_RD	Cross Street: CONFERENCE_DR	Location: E
ADA ID: 569A44D26C1F	Ramp Type: PerpDiag	Initial Pass/Fail: Fail	Overall Compliance: No
Severity Score: 21.25			
Codes/Mitigation Info/Possible Solution		Field Measurements/Component Compliance

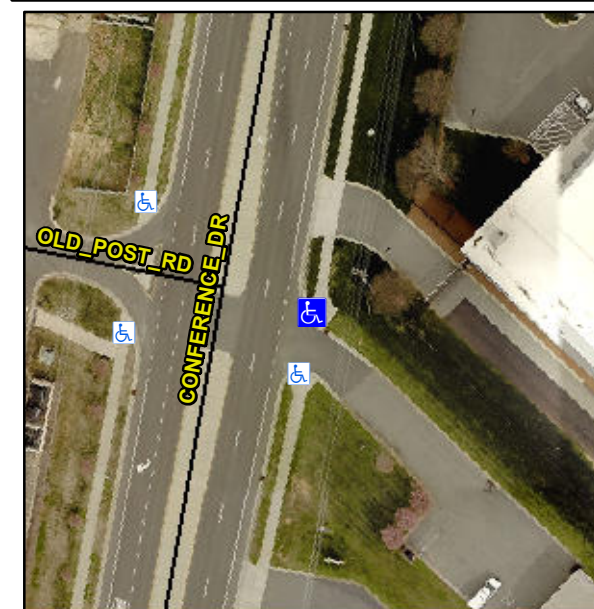
**Not Found, R304.5.1, R304.5.3**

Compliance	Description	Data	Compliance	Description	Data
N/A	Ramp Length (in)	66.0	Yes	Ramp Slope (%)	6.3
No	Ramp Width (in)	47.5	No	Ramp XSlope (%)	5.4
N/A	Flare Type LT	N/A	N/A	Flare Type RT	N/A
N/A	Flare Slope LT (%)	N/A	N/A	Flare Slope RT (%)	N/A
N/A	Flare Traversable LT?	N/A	N/A	Flare Traversable RT?	N/A
N/A	Landing Length (in)	N/A	N/A	DWS Provided?	N/A
N/A	Landing Width (in)	N/A	N/A	DWS Contrast?	N/A
N/A	Landing Slope (%)	N/A	N/A	DWS Length (in)	N/A
N/A	Landing X Slope (%)	N/A	N/A	DWS Full Width?	N/A
N/A	Landing Curb? (Y/N)	N/A	N/A	DWS Offset (in)	N/A
N/A	Shared Landing?	N/A			
N/A	Gutter Ponding?	N/A	N/A	Gutter Slope (%)	N/A
N/A	Gutter Lip Ht (in)	N/A	N/A	Gutter X Slope (%)	N/A
N/A	Painted X Walk1?	No	N/A	Painted X Walk2?	No
	X Walk 1 Direction	To W		X Walk 2 Direction	To SW
N/A	X Walk 1 Width (in)	N/A	N/A	X Walk 2 Width (in)	N/A
	X Walk 1 Slope (%)	2.9		X Walk 2 Slope (%)	2.8
	X Walk 1 X Slope (%)	1.2		X Walk 2 X Slope (%)	3.4

N/A	Ramp inside XWalk1?	N/A	N/A	Ramp inside XWalk2?	N/A
	Road Slope (%)	3.3	N/A	Clear Space?	N/A
	Road X Slope (%)	1.1	N/A	Clear Space to XWalk (in)	N/A
N/A	Any Obstructions?	N/A	N/A	Storm Grate/Utility Hazard?	N/A
	Obstruction Type			Storm Grate/Utility Type	
		N/A			N/A
			Yes	Surface Condition? (G/P)	Good

**Remove & Replace Curb Ramp With Two New Directional Ramps or Equivalent.**
