Access Compliance Report

Public Rights-of-Way (Curb Ramps)

Intersection ID: 7057	Main Street: KENDRICK_AV	Cross Street: STATESVILLE_RD	Location: NE
ADA ID: 569D1D3247C0	Ramp Type: Directional1	Initial Pass/Fail: Fail	Overall Compliance: No
Severity Score: 1.25			
Codes/Mitigation Info/Possible Solution		Field Measurements/Component Compliance

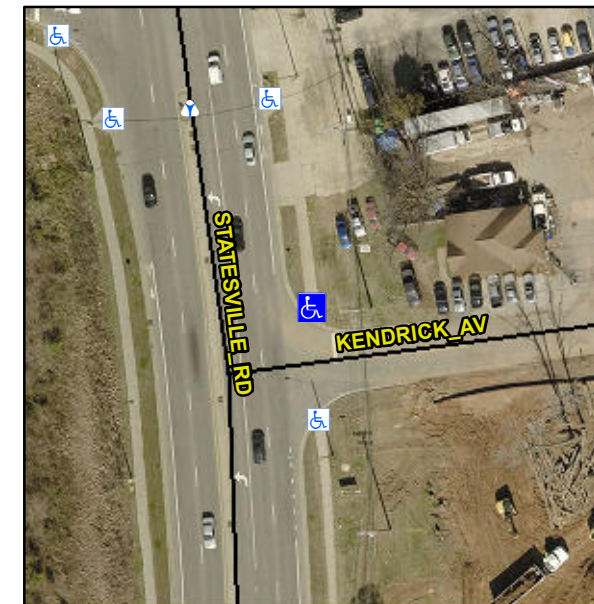
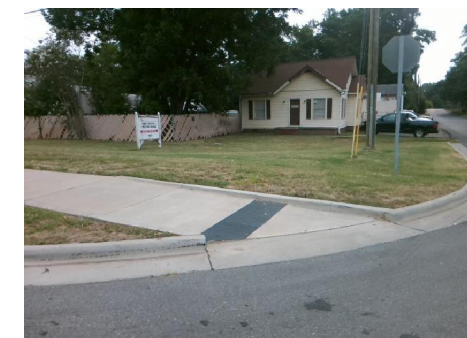
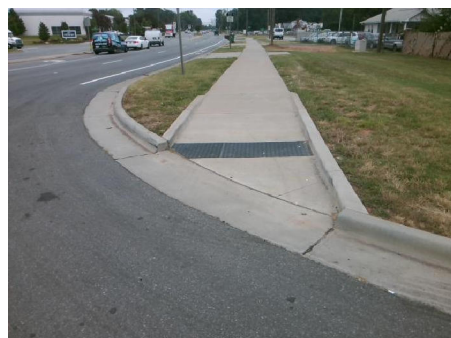
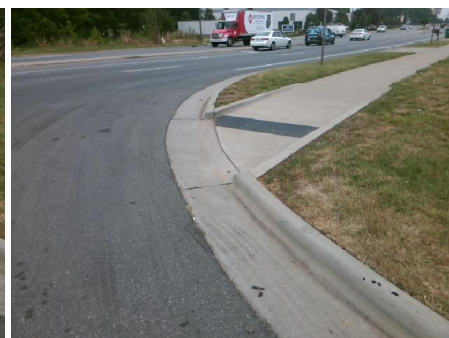
R304.5.3

Compliance	Description	Data	Compliance	Description	Data
N/A	Ramp Length (in)	138.5	N/A	Grade Break?	N/A
Yes	Ramp Width (in)	77.5	N/A	Grade Break Slope (%)	0.0
Yes	Ramp Slope (%)	6.4	N/A	Grade Break XSlope (%)	0.0
No	Ramp XSlope (%)	2.7			
N/A	Flare Type LT	N/A	N/A	Flare Type RT	N/A
N/A	Flare Slope LT (%)	N/A	N/A	Flare Slope RT (%)	0.0
N/A	Flare Traversable LT?	N/A	N/A	Flare Traversable RT?	N/A
N/A	Landing Length (in)	0.0	N/A	DWS Provided?	N/A
N/A	Landing Width (in)	0.0	N/A	DWS Contrast?	N/A
N/A	Landing Slope (%)	0.0	N/A	DWS Length (in)	N/A
N/A	Landing X Slope (%)	0.0	N/A	DWS Full Width?	N/A
N/A	Landing Curb? (Y/N)	N/A	N/A	DWS Offset LT (in)	N/A
N/A	Shared Landing?	N/A	N/A	DWS Offset RT (in)	N/A
N/A	Gutter Ponding?	0.0	N/A	Gutter Slope (%)	N/A
N/A	Gutter Lip Ht (in)	0.0	N/A	Gutter X Slope (%)	N/A
N/A	Painted X Walk1?	No		Road Slope (%)	0.8
	X Walk 1 Direction	To S		Road X Slope (%)	1.5
	X Walk 1 Width (in)	N/A		Clear Space?	N/A

X Walk 1 Slope (%)	0.8	N/A	Clear Space to XWalk (in)	N/A
	X Walk 1 X Slope (%)	1.5	N/A	Storm Grate/Utility Hazard?	N/A
N/A	Ramp inside XWalk1?	N/A		Storm Grate/Utility Type	
N/A	Any Obstructions?	N/A			N/A
	Obstruction Type		Yes	Surface Condition? (G/P)	Good
			N/A	Curb Slope (%)	N/A

Possible Solutions:

Remove & Replace Entire Ramp.

Total Cost: \$ 1600.00
