Intersection ID: 10023016	Main Street: CENTER_PARK_DR	Cross Street: N/A	Location:	SW
ADA ID: 56AFB8E0226F	Ramp Type: PerpDiag	Initial Pass/Fail: Fail	Overall Compliance: No	Severity Score: 25

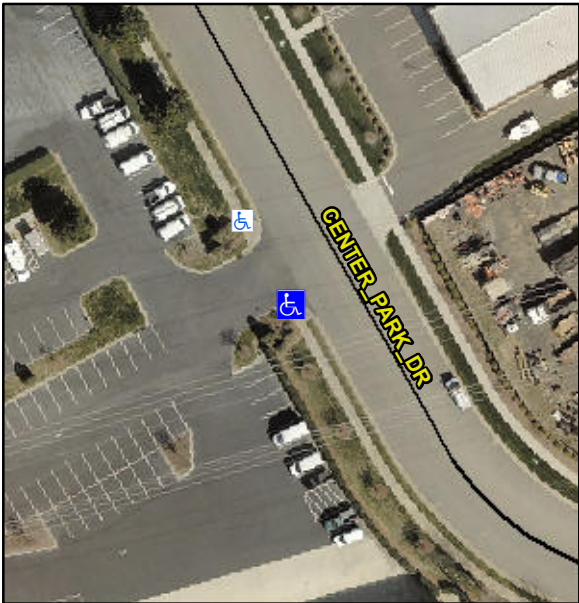
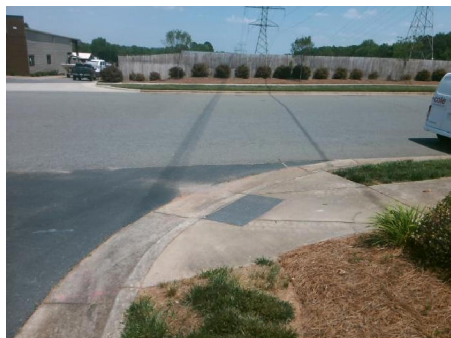
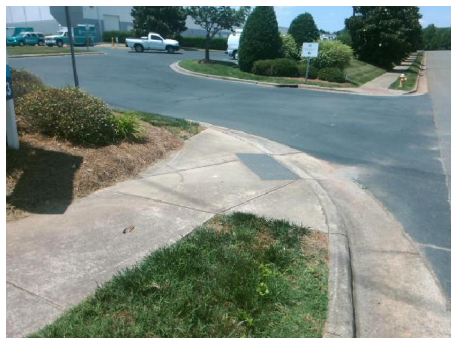
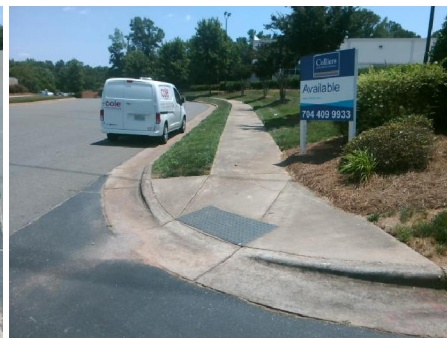
Possible Solutions:		Compliance	Description	Data	Compliance	Description	Data
	Remove & Replace Curb Ramp With Two New Directional Ramps or Equivalent.		N/A	Ramp Length (in)	76.0	No	Ramp Slope (%)	9.4
			Yes	Ramp Width (in)	48.0	No	Ramp XSlope (%)	6.7
			N/A	Flare Type LT	N/A	N/A	Flare Type RT	N/A
			N/A	Flare Slope LT (%)	N/A	N/A	Flare Slope RT (%)	N/A
			N/A	Flare Traversable LT?	N/A	N/A	Flare Traversable RT?	N/A
			N/A	Landing Length (in)	N/A	N/A	DWS Provided?	N/A
	Surveyor Notes:		N/A	Landing Width (in)	N/A	N/A	DWS Contrast?	N/A
			N/A	Landing Slope (%)	N/A	N/A	DWS Length (in)	N/A
			N/A	Landing X Slope (%)	N/A	N/A	DWS Full Width?	N/A
PROW/ADA:		N/A	Landing Curb? (Y/N)	N/A	N/A	DWS Offset (in)	N/A	
				N/A	Shared Landing?	N/A		
		Not Found, R304.2.2, R304.5.3		N/A	Gutter Ponding?	N/A	N/A	Gutter Slope (%)
		N/A	Gutter Lip Ht (in)	N/A	N/A	Gutter X Slope (%)	N/A

N/A	Painted X Walk1?	No	N/A	Painted X Walk2?	No	
			X Walk 1 Direction	To E		X Walk 2 Direction	To N	
		N/A	X Walk 1 Width (in)	N/A	N/A	X Walk 2 Width (in)	N/A	
			X Walk 1 Slope (%)	3.1		X Walk 2 Slope (%)	0.2	
			X Walk 1 X Slope (%)	2.0		X Walk 2 X Slope (%)	6.0	
		N/A	Ramp inside XWalk1?	N/A	N/A	Ramp inside XWalk2?	N/A	
			Road Slope (%)	1.4	N/A	Clear Space?	N/A	
			Road X Slope (%)	0.6	N/A	Clear Space to XWalk (in)	N/A	
		N/A	Any Obstructions?	N/A	N/A	Storm Grate/Utility Hazard?	N/A	
			Obstruction Type			Storm Grate/Utility Type		
				N/A				N/A
					Yes	Surface Condition? (G/P)	Good
