Access Compliance Report

Public Rights-of-Way

(Curb Ramps)

Intersection ID: 14326	Main Street: BALDWIN_AV	Cross Street: LUTHER_ST	Location: W
ADA ID: 56B2DAF76301	Ramp Type: PerpDiag	Initial Pass/Fail: Fail	Overall Compliance: No
Codes/Mitigation Info/Possible Solution		Field Measurements/Component Compliance

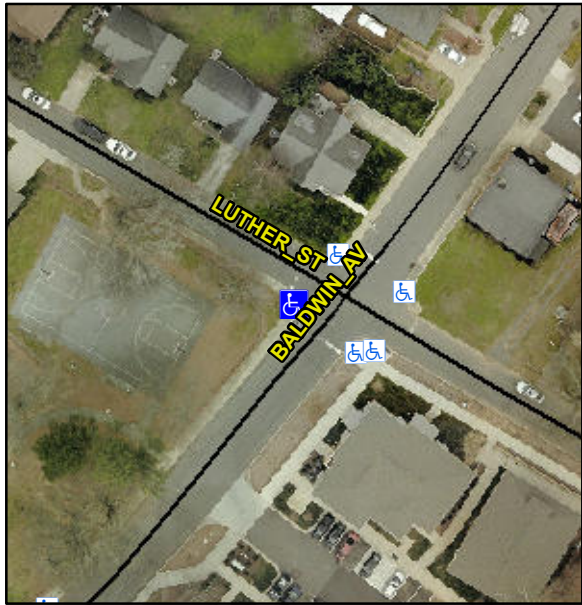
Possible Solutions:							
	Remove & Replace Curb Ramp With Two New Directional Ramps or Equivalent.							
	Surveyor Notes:							
	N/A							
	PROW/ADA:							
	Not Found, R304.2.2, R304.5.3							
	Street 1 Name	BALDWIN AV	Compliance	Description	Data	Compliance	Description	Data
	Stop Condition-Street 2	StopSign	N/A	Ramp Length (in)	57.0	No	Ramp Slope (%)	9.7
	Street 2 Name	LUTHER ST	Yes	Ramp Width (in)	48.0	No	Ramp XSlope (%)	3.5
	Stop Condition-Street 1	StopSign	N/A	Flare Type LT	N/A	N/A	Flare Type RT	N/A
		N/A	Flare Slope LT (%)	N/A	N/A	Flare Slope RT (%)	N/A	
		N/A	Flare Traversable LT?	N/A	N/A	Flare Traversable RT?	N/A	
		N/A	Landing Length (in)	N/A	N/A	DWS Provided?	N/A	
		N/A	Landing Width (in)	N/A	N/A	DWS Contrast?	N/A	
		N/A	Landing Slope (%)	N/A	N/A	DWS Length (in)	N/A	
		N/A	Landing X Slope (%)	N/A	N/A	DWS Full Width?	N/A	
		N/A	Landing Curb? (Y/N)	N/A	N/A	DWS Offset (in)	N/A	
		N/A	Shared Landing?	N/A
