Access Compliance Report

Public Rights-of-Way

(Curb Ramps)

Intersection ID: N/A	Main Street: YORK_CENTER	Cross Street: N/A	Location: SW
ADA ID: 56B94E8F5A27	Ramp Type: PerpDiag	Initial Pass/Fail: Fail	Overall Compliance: No
Codes/Mitigation Info/Possible Solution		Field Measurements/Component Compliance	
Severity Score: 12.5

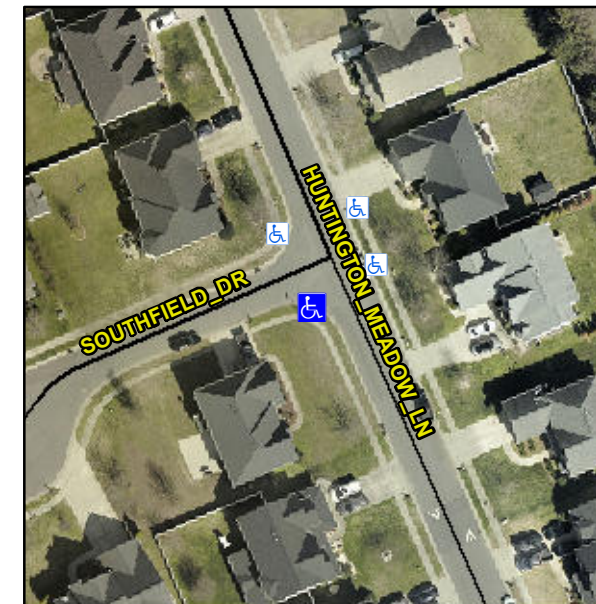
Compliance	Description	Data	Compliance	Description	Data
N/A	Ramp Length (in)	47.0	No	Ramp Slope (%)	10.2
Yes	Ramp Width (in)	48.0	Yes	Ramp XSlope (%)	1.5
N/A	Flare Type LT	N/A	N/A	Flare Type RT	N/A
N/A	Flare Slope LT (%)	N/A	N/A	Flare Slope RT (%)	N/A
N/A	Flare Traversable LT?	N/A	N/A	Flare Traversable RT?	N/A
N/A	Landing Length (in)	N/A	N/A	DWS Provided?	N/A
N/A	Landing Width (in)	N/A	N/A	DWS Contrast?	N/A
N/A	Landing Slope (%)	N/A	N/A	DWS Length (in)	N/A
N/A	Landing X Slope (%)	N/A	N/A	DWS Full Width?	N/A
N/A	Landing Curb? (Y/N)	N/A	N/A	DWS Offset (in)	N/A
N/A	Shared Landing?	N/A			
N/A	Gutter Ponding?	N/A	N/A	Gutter Slope (%)	N/A
N/A	Gutter Lip Ht (in)	N/A	N/A	Gutter X Slope (%)	N/A
N/A	Painted X Walk1?	No	N/A	Painted X Walk2?	No
	X Walk 1 Direction	To E		X Walk 2 Direction	To N
N/A	X Walk 1 Width (in)	N/A	N/A	X Walk 2 Width (in)	N/A
	X Walk 1 Slope (%)	3.1		X Walk 2 Slope (%)	2.1
	X Walk 1 X Slope (%)	0.5		X Walk 2 X Slope (%)	0.9

N/A	Ramp inside XWalk1?	N/A	N/A	Ramp inside XWalk2?	N/A
	Road Slope (%)	0.5	N/A	Clear Space?	N/A
	Road X Slope (%)	4.6	N/A	Clear Space to XWalk (in)	N/A
N/A	Any Obstructions?	N/A	N/A	Storm Grate/Utility Hazard?	N/A
	Obstruction Type			Storm Grate/Utility Type	
		N/A			N/A
			Yes	Surface Condition? (G/P)	Good

Possible Solutions:

Remove & Replace Curb Ramp With Two New Directional Ramps or Equivalent.

PROW/ADA:

R304.2.2

Total Cost: \$ 3200.00
