Access Compliance Report

Public Rights-of-Way

(Curb Ramps)

Intersection ID: 30086	Main Street: DEVONBRIDGE_LN	Cross Street: DEVONGATE_LN	Location: S
ADA ID: 56C672180060	Ramp Type: PerpDiag	Initial Pass/Fail: Fail	Overall Compliance: No
Severity Score: 33.75			
Codes/Mitigation Info/Possible Solution		Field Measurements/Component Compliance

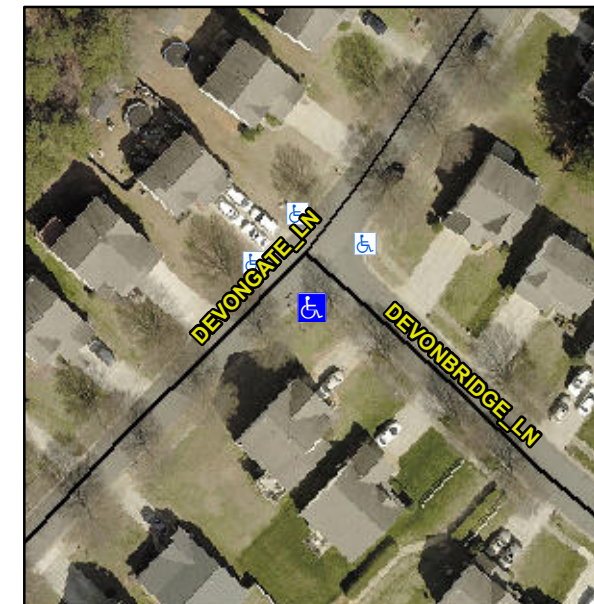
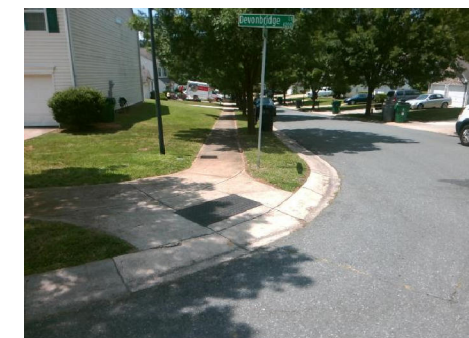
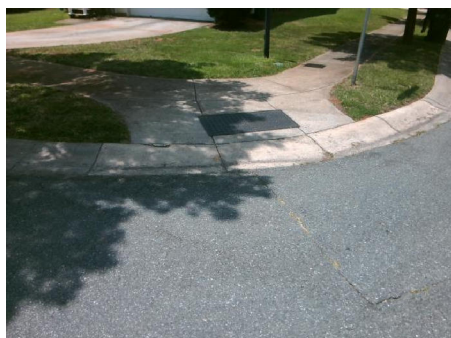
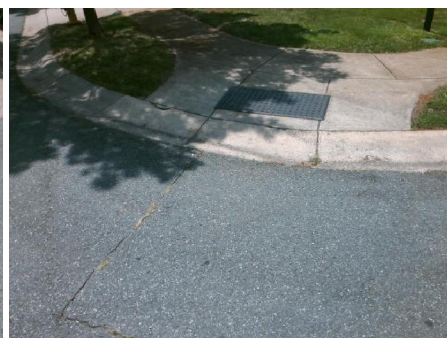
Not Found, R304.5.1, R304.2.2

Compliance	Description	Data	Compliance	Description	Data
N/A	Ramp Length (in)	51.0	No	Ramp Slope (%)	20.0
No	Ramp Width (in)	42.0	Yes	Ramp XSlope (%)	0.6
N/A	Flare Type LT	N/A	N/A	Flare Type RT	N/A
N/A	Flare Slope LT (%)	N/A	N/A	Flare Slope RT (%)	N/A
N/A	Flare Traversable LT?	N/A	N/A	Flare Traversable RT?	N/A
N/A	Landing Length (in)	N/A	N/A	DWS Provided?	N/A
N/A	Landing Width (in)	N/A	N/A	DWS Contrast?	N/A
N/A	Landing Slope (%)	N/A	N/A	DWS Length (in)	N/A
N/A	Landing X Slope (%)	N/A	N/A	DWS Full Width?	N/A
N/A	Landing Curb? (Y/N)	N/A	N/A	DWS Offset (in)	N/A
N/A	Shared Landing?	N/A			
N/A	Gutter Ponding?	N/A	N/A	Gutter Slope (%)	N/A
N/A	Gutter Lip Ht (in)	N/A	N/A	Gutter X Slope (%)	N/A
N/A	Painted X Walk1?	No	N/A	Painted X Walk2?	No
	X Walk 1 Direction	To NE		X Walk 2 Direction	To NW
N/A	X Walk 1 Width (in)	N/A	N/A	X Walk 2 Width (in)	N/A
	X Walk 1 Slope (%)	0.1		X Walk 2 Slope (%)	0.4
	X Walk 1 X Slope (%)	2.2		X Walk 2 X Slope (%)	6.1

N/A	Ramp inside XWalk1?	N/A	N/A	Ramp inside XWalk2?	N/A
	Road Slope (%)	4.1	N/A	Clear Space?	N/A
	Road X Slope (%)	8.9	N/A	Clear Space to XWalk (in)	N/A
N/A	Any Obstructions?	N/A	N/A	Storm Grate/Utility Hazard?	N/A
	Obstruction Type			Storm Grate/Utility Type	
		N/A			N/A
			Yes	Surface Condition? (G/P)	Good

Remove & Replace Curb Ramp With Two New Directional Ramps or Equivalent.
