Access Compliance Report Public Rights-of-Way (Curb Ramps)

Intersection ID: 46914	Main Str	eet: PONDEROSA_PINE_LN	J C	Cross Street: HARRISBURG RD				Location:	w
								10	
ADA ID: 56C89FAACD16 Ramp Type: Perp			I	Initial Pass/Fail: Fail Overall Compliance: No					10
Codes/Mitigation Info/Possible Solution				Field Measurements/Component Compliance					
A Strings and All	They South	Possible Solutions:		<u>Comp</u>	liance Description	Data	Comp	liance Description	Data
N MA MERSEN	States 1.1	Remove & Replace Entire	Ramp.	N/A	Ramp Length (in)	93.5	Yes	Ramp Slope (%)	7.0
A A				No	Ramp Width (in)	45.0	No	Ramp XSlope (%)	3.4
		1		N/A	Flare Type LT	N/A	N/A	Flare Type RT	N/A
A CONTRACTOR	KA			N/A	Flare Slope LT (%)	N/A	N/A	Flare Slope RT (%)	N/A
the second second				N/A	Flare Traversable LT?	N/A	N/A	Flare Traversable RT?	N/A
E B				N/A	Landing Length (in)	N/A	N/A	DWS Provided?	N/A
	R	Surveyor Notes:		N/A	Landing Width (in)	N/A	N/A	DWS Contrast?	N/A
	OF A A	N/A		N/A	Landing Slope (%)	N/A	N/A	DWS Length (in)	N/A

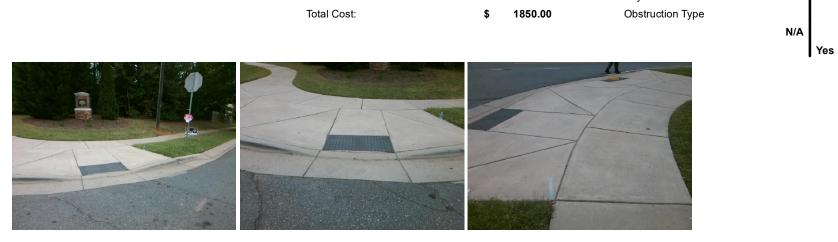
the second s	AL AN			N/A	Landing X Slope (%)	N/A	N/A	DWS Full Width?	N/A
	CONTRACTOR OF			N/A	Landing Curb? (Y/N)	N/A	N/A	DWS Offset (in)	N/A
	Partit State			N/A	Shared Landing?	N/A			
	A BUTT	PROW/ADA:		N/A	Gutter Ponding?	N/A	N/A	Gutter Slope (%)	N/A
	and the second	Not Found, R304.5.1, R30	4.5.3	N/A	Gutter Lip Ht (in)	N/A	N/A	Gutter X Slope (%)	N/A
	1 Anna			N/A	Painted X Walk1?	No	N/A	Painted X Walk2?	N/A
and the second	AND THE				X Walk 1 Direction	To NE		X Walk 2 Direction	N/A
				N/A	X Walk 1 Width (in)	N/A	N/A	X Walk 2 Width (in)	N/A
Street 1 Name PON	DEROSA PINE LN				X Walk 1 Slope (%)	2.8		X Walk 2 Slope (%)	N/A
Stop Condition-Street 2	StopSign				X Walk 1 X Slope (%)	1.5		X Walk 2 X Slope (%)	N/A
Street 2 Name	N/A			N/A	Ramp inside XWalk1?	N/A	N/A	Ramp inside XWalk2?	N/A
Stop Condition-Street 1	N/A				Road Slope (%)	N/A	N/A	Clear Space?	N/A
					Road X Slope (%)	N/A	N/A	Clear Space to XWalk (in)	N/A

N/A	Any Obstructions?	N/A	N/A	Storm Grate/Utility Hazard?	N/A
		Total Cost:	\$ 185	0.00	Obstruction Type			Storm Grate/Utility Type	
						N/A			N/A
