Access Compliance Report

Public Rights-of-Way

(Curb Ramps)

Intersection ID: 44464	Main Street: BAYVIEW_PY	Cross Street: VALCOURT_RD	Location: NE
ADA ID: 56D8B4C4B850	Ramp Type: PerpDiag	Initial Pass/Fail: Fail	Overall Compliance: No
Severity Score: 17.5			
Codes/Mitigation Info/Possible Solution		Field Measurements/Component Compliance

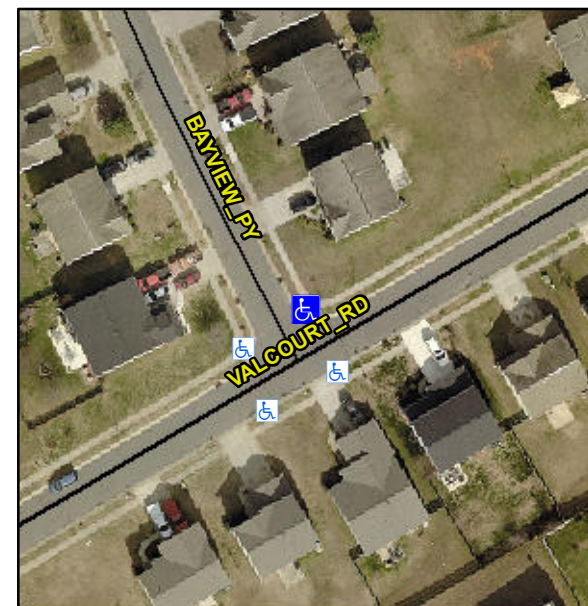
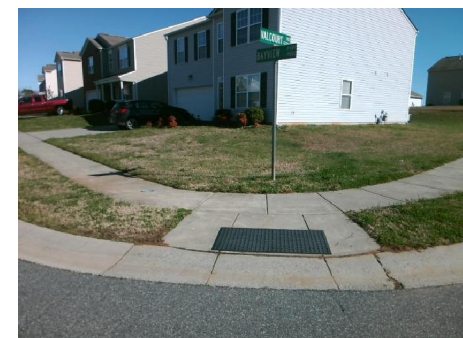
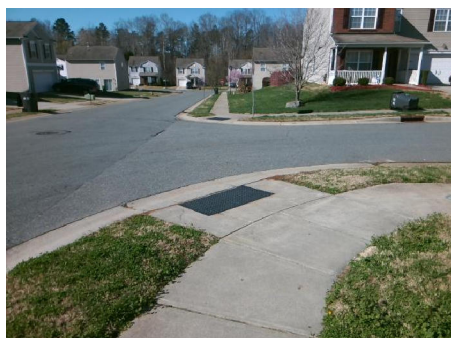
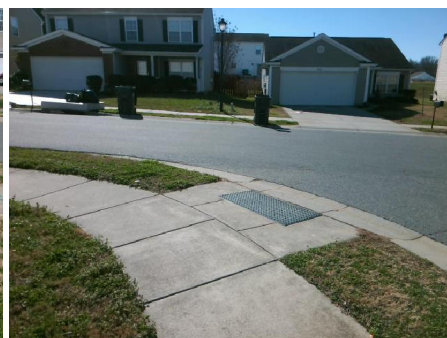
Not Found, R304.5.1

Compliance	Description	Data	Compliance	Description	Data
N/A	Ramp Length (in)	49.0	Yes	Ramp Slope (%)	5.7
No	Ramp Width (in)	33.5	Yes	Ramp XSlope (%)	1.2
N/A	Flare Type LT	N/A	N/A	Flare Type RT	N/A
N/A	Flare Slope LT (%)	N/A	N/A	Flare Slope RT (%)	N/A
N/A	Flare Traversable LT?	N/A	N/A	Flare Traversable RT?	N/A
N/A	Landing Length (in)	N/A	N/A	DWS Provided?	N/A
N/A	Landing Width (in)	N/A	N/A	DWS Contrast?	N/A
N/A	Landing Slope (%)	N/A	N/A	DWS Length (in)	N/A
N/A	Landing X Slope (%)	N/A	N/A	DWS Full Width?	N/A
N/A	Landing Curb? (Y/N)	N/A	N/A	DWS Offset (in)	N/A
N/A	Shared Landing?	N/A			
N/A	Gutter Ponding?	N/A	N/A	Gutter Slope (%)	N/A
N/A	Gutter Lip Ht (in)	N/A	N/A	Gutter X Slope (%)	N/A
N/A	Painted X Walk1?	No	N/A	Painted X Walk2?	No
	X Walk 1 Direction	To W		X Walk 2 Direction	To S
N/A	X Walk 1 Width (in)	N/A	N/A	X Walk 2 Width (in)	N/A
	X Walk 1 Slope (%)	4.2		X Walk 2 Slope (%)	2.7
	X Walk 1 X Slope (%)	1.1		X Walk 2 X Slope (%)	3.3

N/A	Ramp inside XWalk1?	N/A	N/A	Ramp inside XWalk2?	N/A
	Road Slope (%)	2.3	N/A	Clear Space?	N/A
	Road X Slope (%)	3.4	N/A	Clear Space to XWalk (in)	N/A
N/A	Any Obstructions?	N/A	N/A	Storm Grate/Utility Hazard?	N/A
	Obstruction Type			Storm Grate/Utility Type	
		N/A			N/A
			Yes	Surface Condition? (G/P)	Good

Remove & Replace Curb Ramp With Two New Directional Ramps or Equivalent.
