Access Compliance Report Public Rights-of-Way (Curb Ramps)

Intersection ID: 10016753Main Street:PUMPERNICKEL_RDCross Street:N/ALocation:SWADA ID: 56DA2EE9D024Ramp Type:PerpInitial Pass/Fail:FailOverall Compliance:NoSeverity Score:12.5

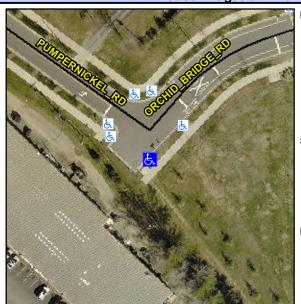
Field Measurements/Component Compliance							
Compliance Description		Data	Compliance Description		Data		
ı	N/A	Ramp Length (in)	96.0	No	Ramp Slope (%)	10.0	
,	Yes	Ramp Width (in)	94.0	Yes	Ramp XSlope (%)	1.7	
1	N/A	Flare Type LT	N/A	N/A	Flare Type RT	N/A	
ı	N/A	Flare Slope LT (%)	N/A	N/A	Flare Slope RT (%)	N/A	
ı	N/A	Flare Traversable LT?	N/A	N/A	Flare Traversable RT?	N/A	
ı	N/A	Landing Length (in)	N/A	N/A	DWS Provided?	N/A	
ı	N/A	Landing Width (in)	N/A	N/A	DWS Contrast?	N/A	
ı	N/A	Landing Slope (%)	N/A	N/A	DWS Length (in)	N/A	
ı	N/A	Landing X Slope (%)	N/A	N/A	DWS Full Width?	N/A	
ı	N/A	Landing Curb? (Y/N)	N/A	N/A	DWS Offset (in)	N/A	
ı	N/A	Shared Landing?	N/A				
ı	N/A	Gutter Ponding?	N/A	N/A	Gutter Slope (%)	N/A	
ı	N/A	Gutter Lip Ht (in)	N/A	N/A	Gutter X Slope (%)	N/A	
ı	N/A	Painted X Walk1?	No	N/A	Painted X Walk2?	N/A	
		X Walk 1 Direction	To NW		X Walk 2 Direction	N/A	
ı	N/A	X Walk 1 Width (in)	N/A	N/A	X Walk 2 Width (in)	N/A

X Walk 1 Slope (%)	0.3		X Walk 2 Slope (%)	N/A	
		X Walk 1 X Slope (%)	0.6		X Walk 2 X Slope (%)	N/A	
ı	N/A	Ramp inside XWalk1?	N/A	N/A	Ramp inside XWalk2?	N/A	
		Road Slope (%)	N/A	N/A	Clear Space?	N/A	
		Road X Slope (%)	N/A	N/A	Clear Space to XWalk (in)	N/A	
ı	N/A	Any Obstructions?	N/A	N/A	Storm Grate/Utility Hazard?	N/A	
		Obstruction Type			Storm Grate/Utility Type		
			N/A			N/A	
				Yes	Surface Condition? (G/P)	Good	
_

Remove & Replace Entire Ramp.

R304.2.2
