# Access Compliance Report

## Public Rights-of-Way

### (Curb Ramps)

Intersection ID: 4576	Main Street: ROCKMEADOW_DR	Cross Street: TRINITY_RD	Location: NW
ADA ID: 56E145F751FA	Ramp Type: Perp	Initial Pass/Fail: Fail	Overall Compliance: No Severity Score: 13.75

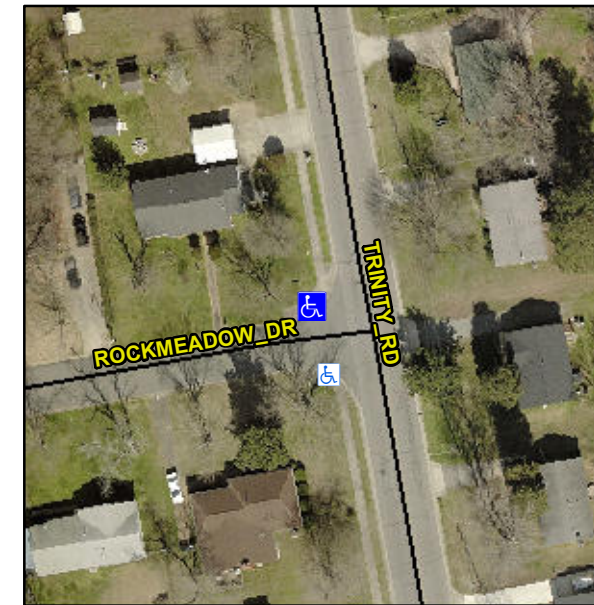
Compliance	Description	Data	Compliance	Description	Data
N/A	Ramp Length (in)	61.5	No	Ramp Slope (%)	9.5
Yes	Ramp Width (in)	48.0	No	Ramp XSlope (%)	3.5
N/A	Flare Type LT	N/A	N/A	Flare Type RT	N/A
N/A	Flare Slope LT (%)	N/A	N/A	Flare Slope RT (%)	N/A
N/A	Flare Traversable LT?	N/A	N/A	Flare Traversable RT?	N/A
N/A	Landing Length (in)	N/A	N/A	DWS Provided?	N/A
N/A	Landing Width (in)	N/A	N/A	DWS Contrast?	N/A
N/A	Landing Slope (%)	N/A	N/A	DWS Length (in)	N/A
N/A	Landing X Slope (%)	N/A	N/A	DWS Full Width?	N/A
N/A	Landing Curb? (Y/N)	N/A	N/A	DWS Offset (in)	N/A
N/A	Shared Landing?	N/A			
N/A	Gutter Ponding?	N/A	N/A	Gutter Slope (%)	N/A
N/A	Gutter Lip Ht (in)	1.0	N/A	Gutter X Slope (%)	N/A
N/A	Painted X Walk1?	No	N/A	Painted X Walk2?	N/A
	X Walk 1 Direction	To S		X Walk 2 Direction	N/A
N/A	X Walk 1 Width (in)	N/A	N/A	X Walk 2 Width (in)	N/A
	X Walk 1 Slope (%)	0.6		X Walk 2 Slope (%)	N/A
	X Walk 1 X Slope (%)	1.3		X Walk 2 X Slope (%)	N/A

N/A	Ramp inside XWalk1?	N/A	N/A	Ramp inside XWalk2?	N/A
	Road Slope (%)	N/A	N/A	Clear Space?	N/A
	Road X Slope (%)	N/A	N/A	Clear Space to XWalk (in)	N/A
N/A	Any Obstructions?	N/A	N/A	Storm Grate/Utility Hazard?	N/A
	Obstruction Type			Storm Grate/Utility Type	
		N/A			N/A
		Yes		Surface Condition? (G/P)	Good

Possible Solutions:

**Remove & Replace Entire Ramp.**

**R304.2.2, R304.5.3**
