Access Compliance Report

Public Rights-of-Way

| Intersection ID: 9610 | Main Street: BARRINGTON_DR | Cross Street: THE_PLAZA | Location: | N |
| ADA ID: 56E8287B4739 | Ramp Type: PerpDiag | Initial Pass/Fail: Fail | Overall Compliance: No | Severity Score: 12.5 |

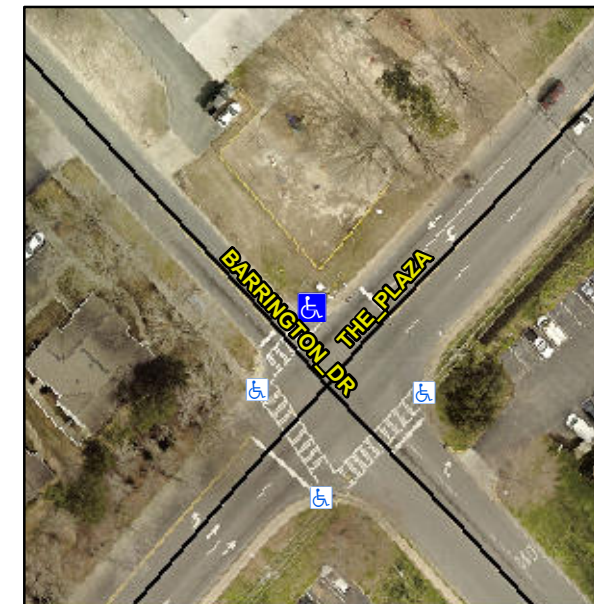
Not Found, R304.2.2

| Compliance | Description | Data | Compliance | Description | Data |
|---|---|---|---|---|---|
| N/A | Ramp Length (in) | 56.0 | No | Ramp Slope (%) | 11.0 |

Remove & Replace Curb Ramp With Two New Directional Ramps or Equivalent.

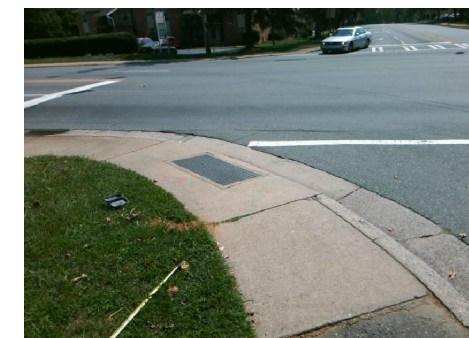
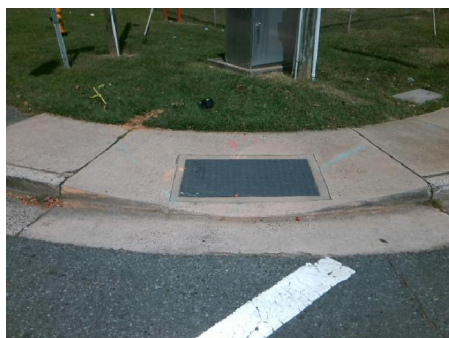
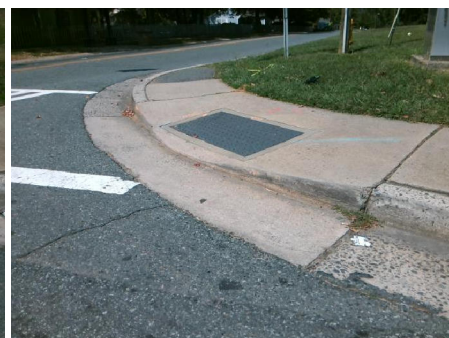
| Compliance | Description | Data | Compliance | Description | Data |
|---|---|---|---|---|---|
| | | | Yes | Surface Condition? (G/P) | Good |
