# Access Compliance Report

## Public Rights-of-Way

| Intersection ID: 15175 | Main Street: SOUTH_BV | Cross Street: POINDEXTER_DR | Location: W |
| ADA ID: 56EC304A14A5 | Ramp Type: Perp | Initial Pass/Fail: Fail | Overall Compliance: No |

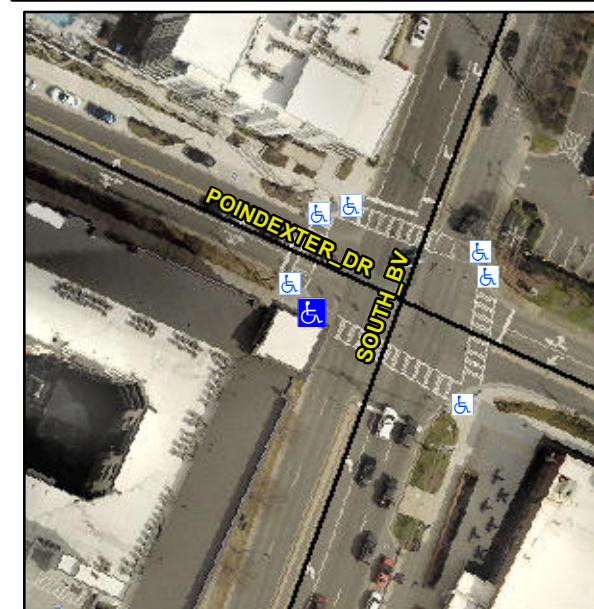
**Not Found, R304.5.1, R304.2.2**

| Compliance | Description | Data | Compliance | Description | Data |
|---|---|---|---|---|---|
| N/A | Ramp Length (in) | 96.0 | No | Ramp Slope (%) | 10.0 |
| No | Ramp Width (in) | 46.0 | Yes | Ramp XSlope (%) | 1.6 |

**Remove & Replace Entire Ramp.**

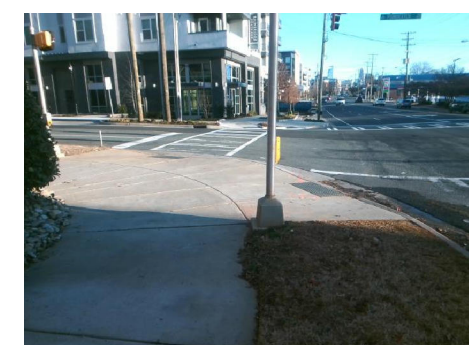
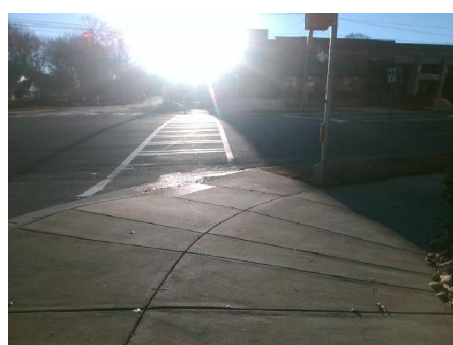
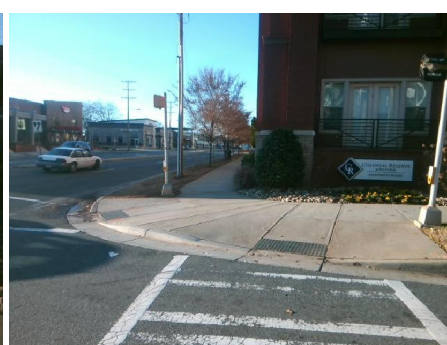
| Compliance | Description | Data | Compliance | Description | Data |
|---|---|---|---|---|---|
| | | Yes | | Surface Condition? (G/P) | Good |
