Access Compliance Report Public Rights-of-Way (Curb Ramps)

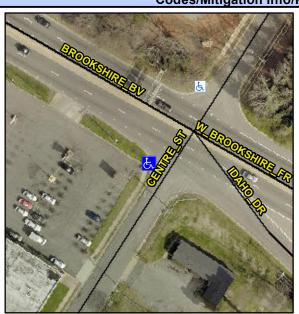
Total Cost: 1850.00

Field Measurements/Component Compliance						
	Compliance Description		Data	Compliance Description		Data
	N/A	Ramp Length (in)	61.0	Yes	Ramp Slope (%)	5.9
	No	Ramp Width (in)	47.5	Yes	Ramp XSlope (%)	0.3
	N/A	Flare Type LT	N/A	N/A	Flare Type RT	N/A
	N/A	Flare Slope LT (%)	N/A	N/A	Flare Slope RT (%)	N/A
	N/A	Flare Traversable LT?	N/A	N/A	Flare Traversable RT?	N/A
	N/A	Landing Length (in)	N/A	N/A	DWS Provided?	N/A
	N/A	Landing Width (in)	N/A	N/A	DWS Contrast?	N/A
	N/A	Landing Slope (%)	N/A	N/A	DWS Length (in)	N/A
	N/A	Landing X Slope (%)	N/A	N/A	DWS Full Width?	N/A
	N/A	Landing Curb? (Y/N)	N/A	N/A	DWS Offset (in)	N/A
	N/A	Shared Landing?	N/A			
	N/A	Gutter Ponding?	N/A	N/A	Gutter Slope (%)	N/A
	N/A	Gutter Lip Ht (in)	0.5	N/A	Gutter X Slope (%)	N/A
	N/A	Painted X Walk1?	No	N/A	Painted X Walk2?	N/A
		X Walk 1 Direction	То Е		X Walk 2 Direction	N/A
	N/A	X Walk 1 Width (in)	N/A	N/A	X Walk 2 Width (in)	N/A
		X Walk 1 Slope (%)	0.3		X Walk 2 Slope (%)	N/A

CENTRE ST Street 1 Name Stop Condition-Street 2 StopSign Street 2 Name N/A Stop Condition-Street 1 N/A
