Access Compliance Report Public Rights-of-Way (Curb Ramps)

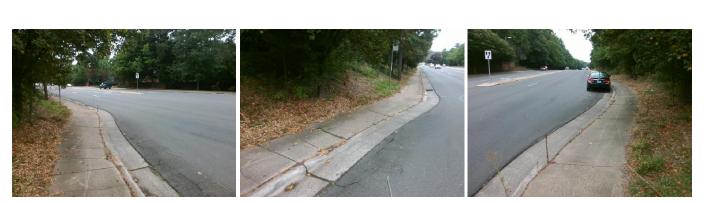
Intersection ID: 22219	Main Street: PARK_RD			Stroot:	SETH THOMAS RD	Location:	NE		
				Cross Street: SETH_THOMAS_RD					
ADA ID: 56F2723D46EA	046EA Ramp Type: Perp		Initial Pass/Fail: Fail Overall Compliance: No				o Severity Score:	12.5	
Codes/Mitigation Info/Possible Solution			Field Measurements/Component Compliance						
	Ser A	Possible Solutions:	Compliance Description Data Con			Comp	mpliance Description Data		
the second second second		Remove & Replace Entire Ramp		N/A	Ramp Length (in)	58.0	No	Ramp Slope (%)	10.5

1.00			Yes	Ramp Width (in)	260.0	Yes	Ramp XSlope (%)	1.9
	S. AN	19. In 19		N/A	Flare Type LT	N/A	N/A	Flare Type RT	N/A
	A Frank			N/A	Flare Slope LT (%)	N/A	N/A	Flare Slope RT (%)	N/A
				N/A	Flare Traversable LT?	N/A	N/A	Flare Traversable RT?	N/A
