## **Access Compliance Report Public Rights-of-Way** (Curb Ramps)

Intersection ID: 5879 Main Street: NEVIN\_RD Cross Street: ZION\_RENAISSANCE\_LN Location: NW **ADA ID: 56FAFE054673** Ramp Type: MedianPerp Initial Pass/Fail: Fail **Overall Compliance: No** Severity Score: 26.25

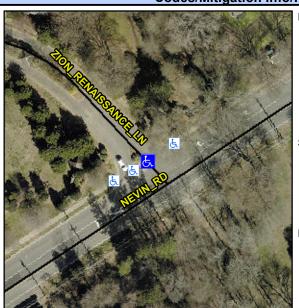
Ramp Slope (%)

Ramp XSlope (%)

PUSSIBLE SOLULION			Field Me
Possible Solutions:	Compli	iance	Description
Remove & Replace Entire Ramp.	N/A	Ramp Length (in)	
·	Yes	Ramp	o Width (in)
	N/A	Flare	Type LT
	N/A	Flare	Slope LT (%)
	N/A	Flare	Traversable LT
	N/A	Land	ing Length (in)
Surveyor Notes:	N/A	Land	ing Width (in)
N/A	N/A	Land	ing Slope (%)
	N/A	Land	ing X Slope (%)
	N/A	Land	ing Curb? (Y/N)
	N/A	Share	ed Landing?
PROW/ADA:	N/A	Gutte	er Ponding?
Not Found, R304.2.2	N/A	Gutte	er Lip Ht (in)
	N/A	Paint	ed X Walk1?
		X Wa	lk 1 Direction
	N/A	X Wa	lk 1 Width (in)
		X Wa	lk 1 Slope (%)

1650.00
