Access Compliance Report

Public Rights-of-Way

(Curb Ramps)

Intersection ID: 6114	Main Street: ATKINS_RIDGE_DR	Cross Street: HARTLEY_HILLS_DR	Location: SE
ADA ID: 570CAA2E7973	Ramp Type: Perp	Initial Pass/Fail: Fail	Overall Compliance: No
Severity Score: 0			
Codes/Mitigation Info/Possible Solution		Field Measurements/Component Compliance

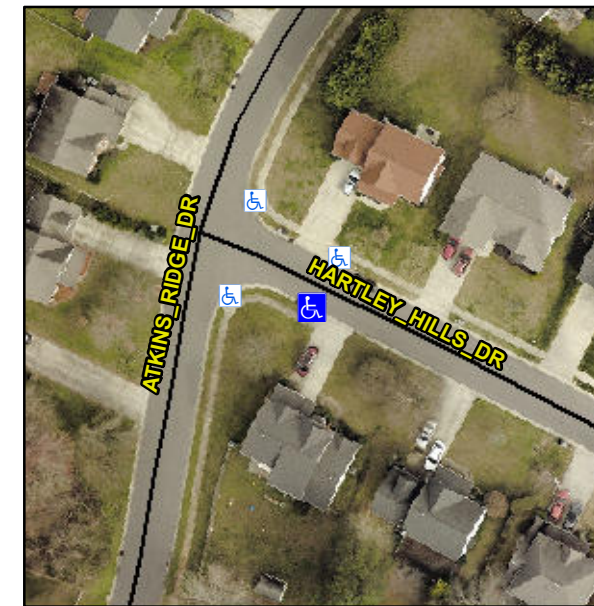
Compliance	Description	Data	Compliance	Description	Data
N/A	Ramp Length (in)	48.0	Yes	Ramp Slope (%)	8.0
Yes	Ramp Width (in)	48.0	Yes	Ramp XSlope (%)	1.2
N/A	Flare Type LT	N/A	N/A	Flare Type RT	N/A
N/A	Flare Slope LT (%)	N/A	N/A	Flare Slope RT (%)	N/A
N/A	Flare Traversable LT?	N/A	N/A	Flare Traversable RT?	N/A
N/A	Landing Length (in)	N/A	N/A	DWS Provided?	N/A
N/A	Landing Width (in)	N/A	N/A	DWS Contrast?	N/A
N/A	Landing Slope (%)	N/A	N/A	DWS Length (in)	N/A
N/A	Landing X Slope (%)	N/A	N/A	DWS Full Width?	N/A
N/A	Landing Curb? (Y/N)	N/A	N/A	DWS Offset (in)	N/A
N/A	Shared Landing?	N/A			
N/A	Gutter Ponding?	N/A	N/A	Gutter Slope (%)	N/A
N/A	Gutter Lip Ht (in)	N/A	N/A	Gutter X Slope (%)	N/A
N/A	Painted X Walk1?	No	N/A	Painted X Walk2?	N/A
	X Walk 1 Direction	To NE		X Walk 2 Direction	N/A
N/A	X Walk 1 Width (in)	N/A	N/A	X Walk 2 Width (in)	N/A
	X Walk 1 Slope (%)	3.3		X Walk 2 Slope (%)	N/A
	X Walk 1 X Slope (%)	5.3		X Walk 2 X Slope (%)	N/A

N/A	Ramp inside XWalk1?	N/A	N/A	Ramp inside XWalk2?	N/A
	Road Slope (%)	N/A	N/A	Clear Space?	N/A
	Road X Slope (%)	N/A	N/A	Clear Space to XWalk (in)	N/A
N/A	Any Obstructions?	N/A	N/A	Storm Grate/Utility Hazard?	N/A
	Obstruction Type			Storm Grate/Utility Type	
		N/A			N/A
			Yes	Surface Condition? (G/P)	Good

Possible Solutions:

Remove & Replace Entire Ramp.
